Inspection Report

Property Address:
1234 New Construction
McKinney TX 75070

Absolute Inspections, LLC

PROPERTY INSPECTION REPORT

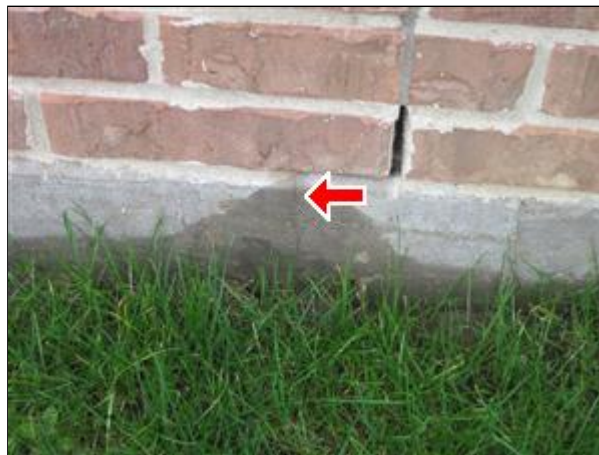
A. Picture 1

(3) Observed a minor (less than 1/8" wide) crack in the side of the foundation. Inspector is unable to determine the extent of this crack or whether it extends through the foundation. Some amount of surface cracking is generally accepted in concrete work. Inspector did not observe other signs or problems that

would indicate abnormal foundation movement either inside or outside of the home. Monitor this area and take further steps, including but not limited to consultation with a licensed structural engineer, if signs of further movement become evident. Locations include but are not limited to: North side of home pictured

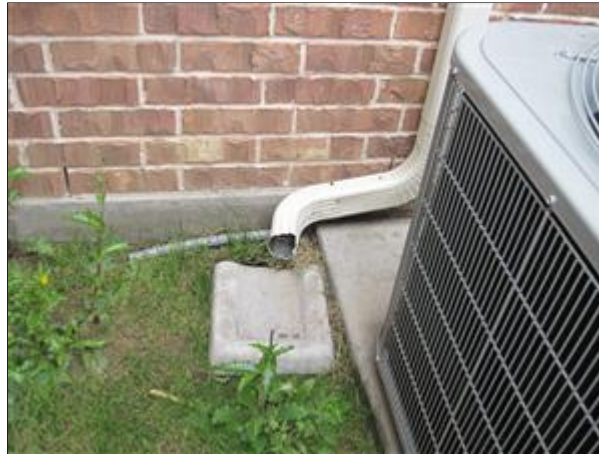
B. Picture 1

(1) Construction and industry standards recommend gutters terminate five feet from the foundation edge, especially in areas where excessive clay soils are prevalent, in order to prevent excessive water from accumulating near the foundation. Excessive water near the foundation can cause foundation related problems. Above ground downspout extensions can make yard care difficult and are often removed by the homeowner, but are functionally acceptable. Below ground extensions are available and should be considered. The absence of extensions may prove acceptable in as long as adequate slope away from the home and splash blocks are provided, but is not recommended. Monitor this condition over time and make corrective action or repair as needed.

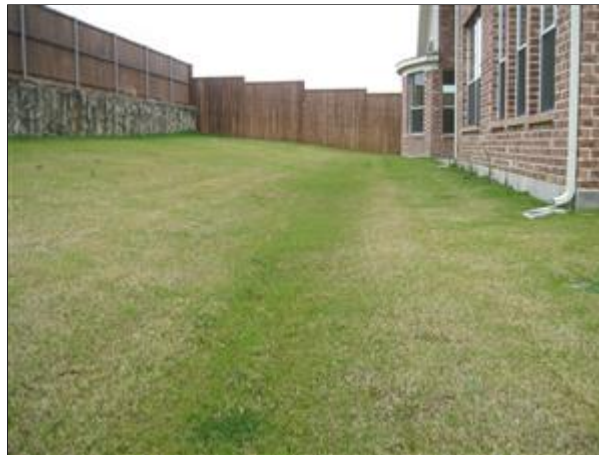
B. Picture 2

(2) Yard at rear of home was observed to have a noticeable slope toward the house that is interrupted by a swale system to route the runoff water around the sides of the house to the front to drain at the street. Please be aware that this feature is important to preventing water from possibly flooding the house and that in a worst case rain/flood situation may not be sufficient. Care and periodic monitoring of the runoff should be undertaken to assure that the system is performing properly. If water is observed to pool and/or not sufficiently flow, repairs or modifications should be made.

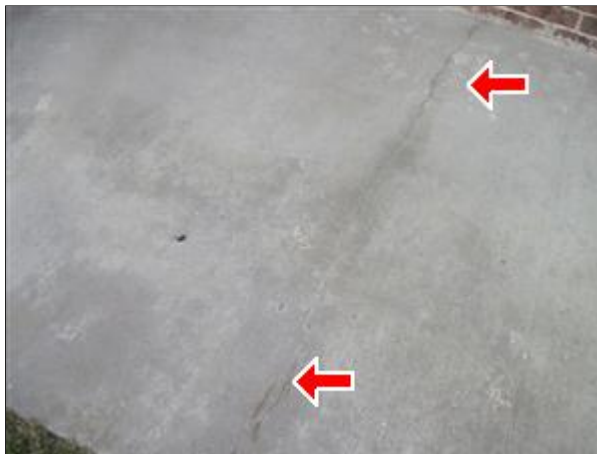
B. Picture 3

(3) Minor cracks (cracks less than 1/8" wide) were observed in the rear patio flatwork. It is virtually impossible for a home inspector to determine whether cracks are caused by structural failure, improper installation techniques or by some other cause, or, if caused by structural failure, whether the cause is active and ongoing. Generally cracks less than 1/8" wide or deflected are considered cosmetic. Recommend verification of proper installation and rebar placement, minor repair/patching and monitoring this area for future movement. If further movement is observed consultation with a structural or concrete expert may be needed.

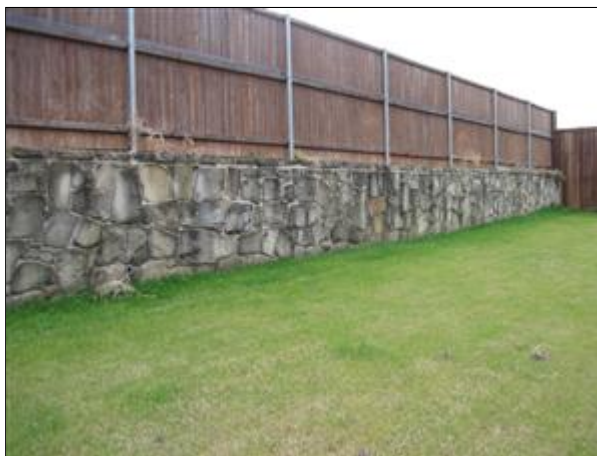
B. Picture 4

(4) Retaining wall present at rear of home. Ownership details unknown, recommend verification of ownership and maintenance responsibilities. Visual inspection only performed. No structural or engineering surveys performed. No warranties, guaranties are made or implied by this inspection.

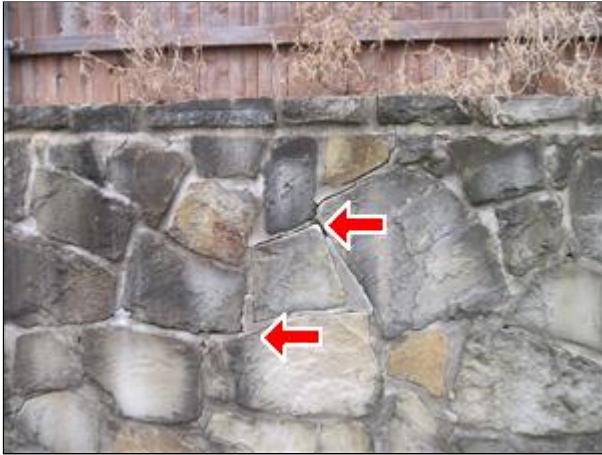
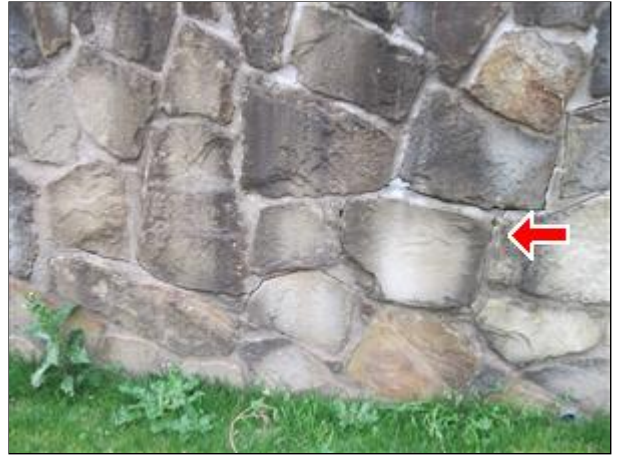
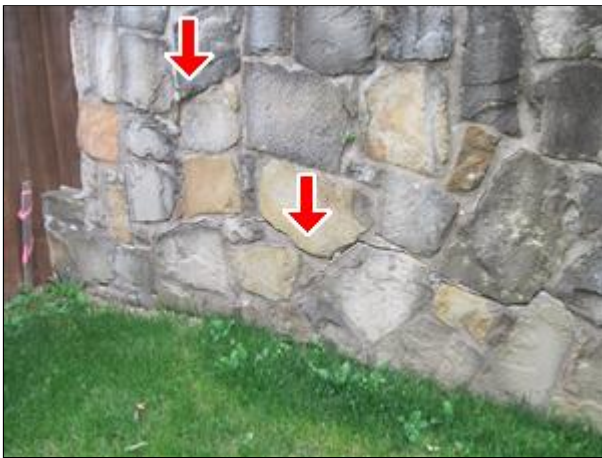
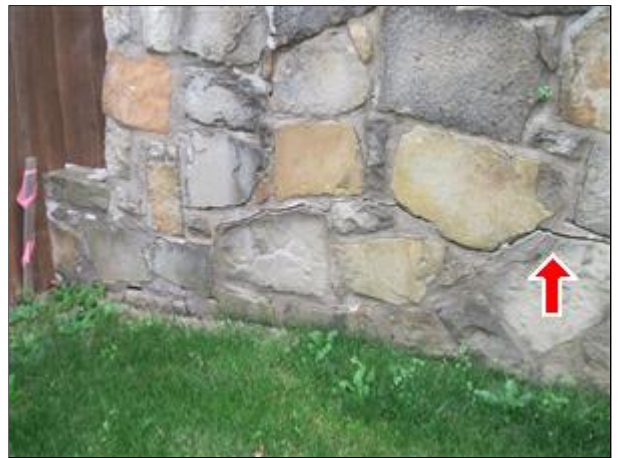
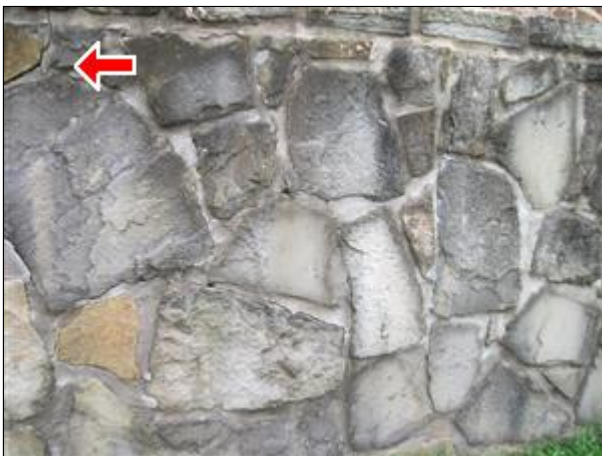
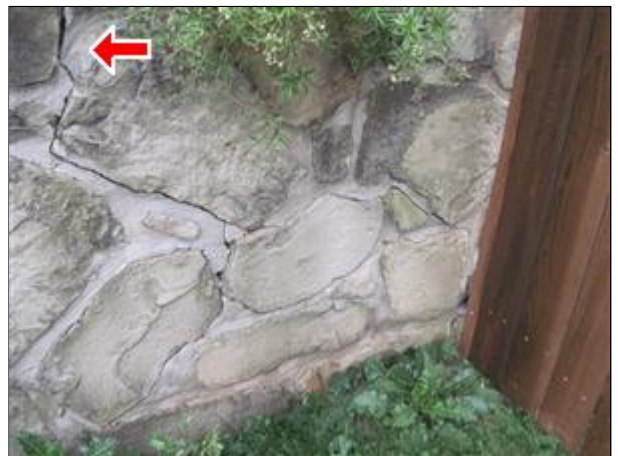
(5) Major cracks (cracks over 1/8" wide) and / or shifting were observed in retaining wall(s). It is virtually impossible for a home inspector to determine whether cracks are caused by structural failure or by some other cause, or, if caused by structural failure, whether the cause is active and ongoing. Recommend further evaluation by a licensed structural engineer or qualified professional.

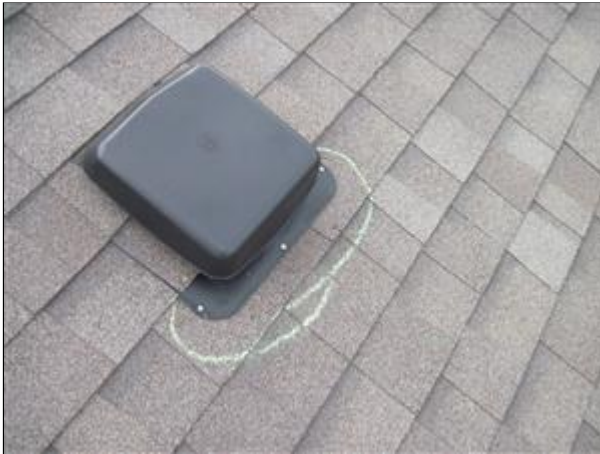
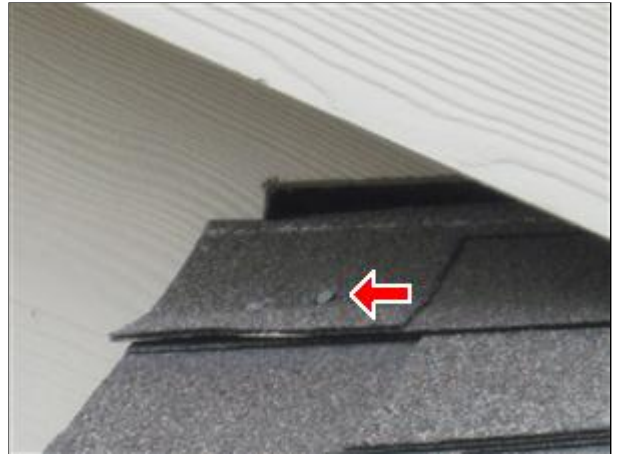
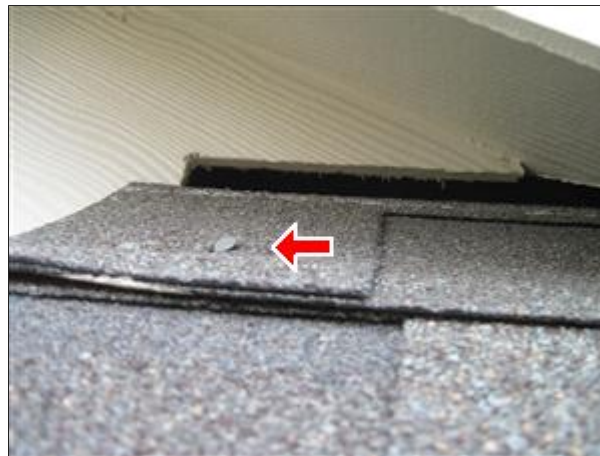
(2) Exposed staples / nail heads / fasteners observed on roof, all exposed fasteners should be sealed with appropriate roofing sealant to prevent water entry. The entire roof surface should be checked and repaired as needed at time of repair.

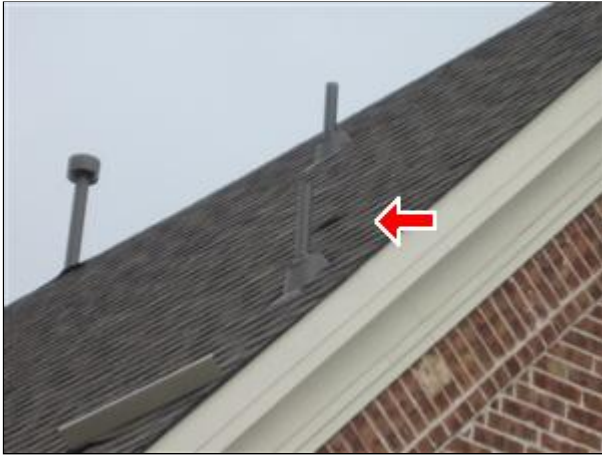
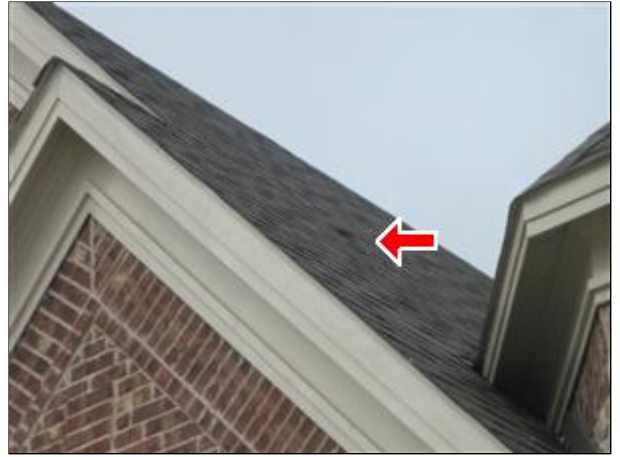
(3) Raised shingle(s) and/or unsealed shingle edges observed. Raised or unsealed shingles can be caused by incompletely driven nails. Other or multiple causes can exist. This condition causes the bottom edge of the shingle to be incompletely sealed to the shingle below it. This can allow high winds to get a "grip" under the shingles and pull them off or cause damage to the roof surface. Recommend review and repair of entire roof area as needed by a qualified roofing contractor. Pictures represent examples, entire roof surface should be carefully checked and repaired as needed at time of repairs.

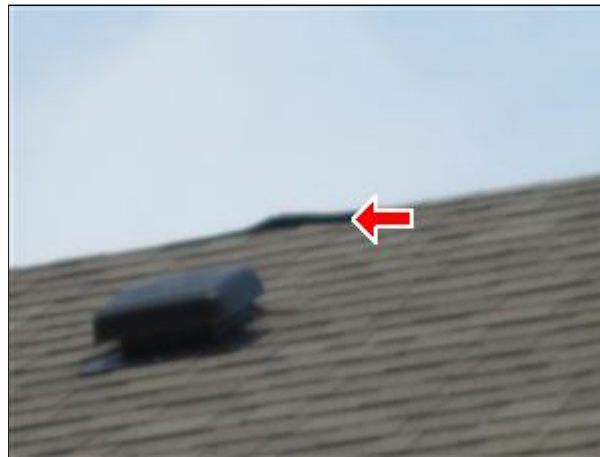
C. Picture 12 Over double car garage

(4) Damaged / Pitted / Cracked shingles observed on roof. Cause of damage not determined. Recommend immediate review of shingles by qualified roofing contractor. Entire roof surface should be examined and repaired as needed at that time.

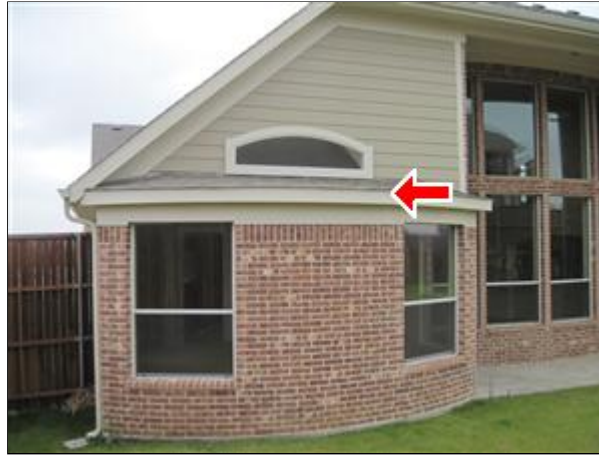
C. Picture 13

(5) Recommend verification of proper underlayment for low slope roof with composition shingles at protruding roof at master bedroom

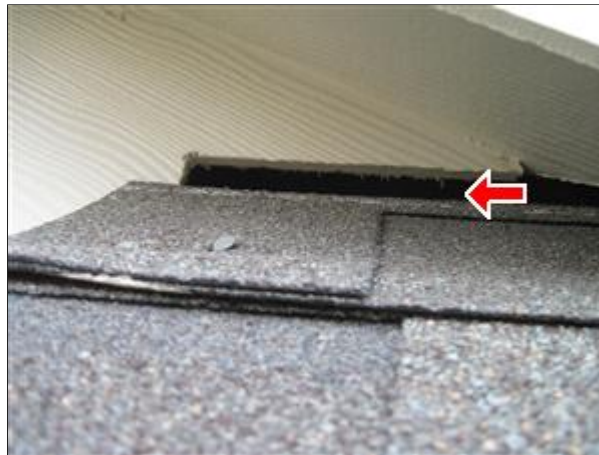
D. Picture 1

(1) Gap at soffit end observed. Should be sealed to prevent pest entry. Locations include but are not limited to: North side above master bath window pictured

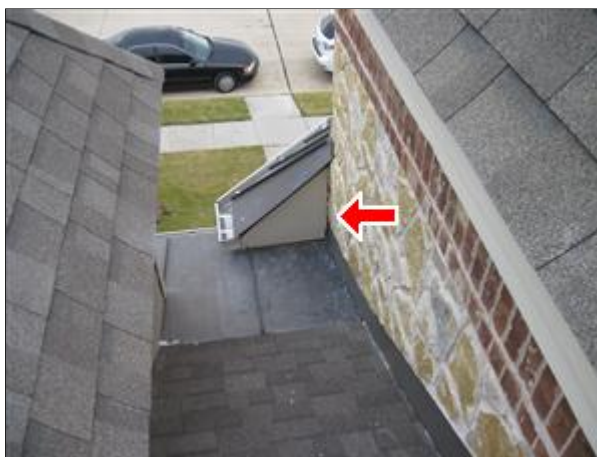
D. Picture 2

(2) Sealant needed at soffit area pictured.

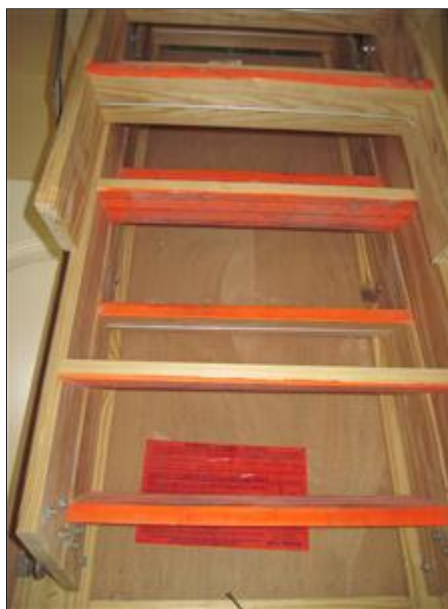
D. Picture 3

(5) Attic access door located inside building envelope and not insulated and or weather stripped. Efficiency concern. We recommend that you consider a product called an "Attic Tent" (you can Google it to find vendors). We have found this is more effective than traditional insulation and weather stripping at sealing this opening.

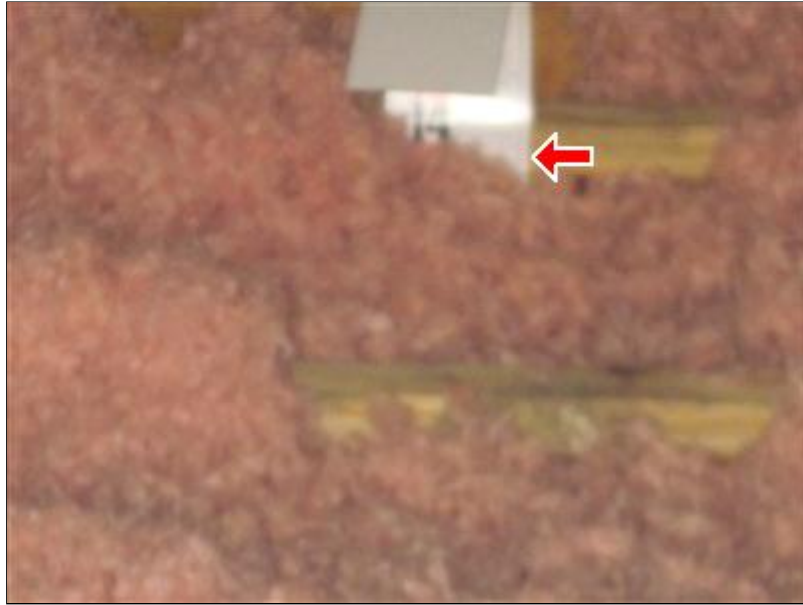
D. Picture 4

(6) Some areas observed to have too little minimum insulation installed. No product sheet was found. Front portion of upper attic observed to have 16 to 18 inches of insulation installed. Rear areas (behind west most HVAC unit) observed to have 10 - 14 inches. Recommend having installer add additional insulation to bring the level to a constant level and verification of required level..

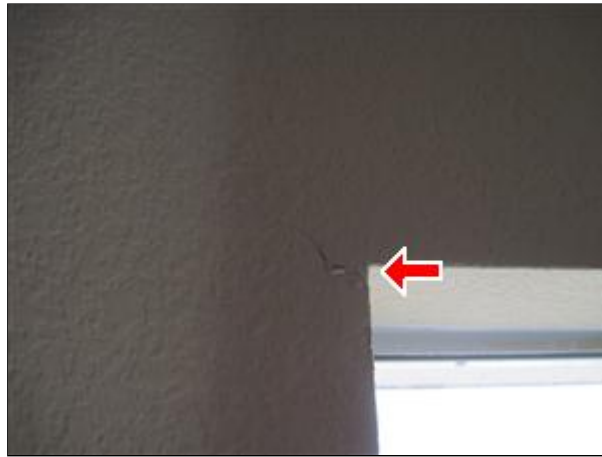
E. Picture 3

(1) Cracking observed at stonework and sill of area pictured in front. Some minor interior cracking was also observed in this area. Did not appear excessive at this time. Monitor the area and consult with a licensed structural engineer if movement becomes excessive.

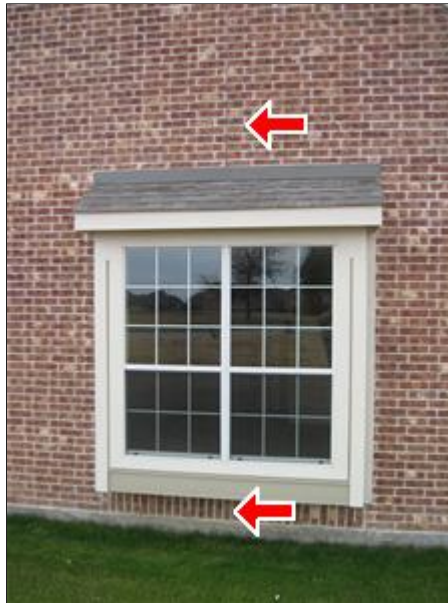
E. Picture 4

(2) North expansion joint is not continued under the window box. Expansion joints should run the entire height of the brick veneer.

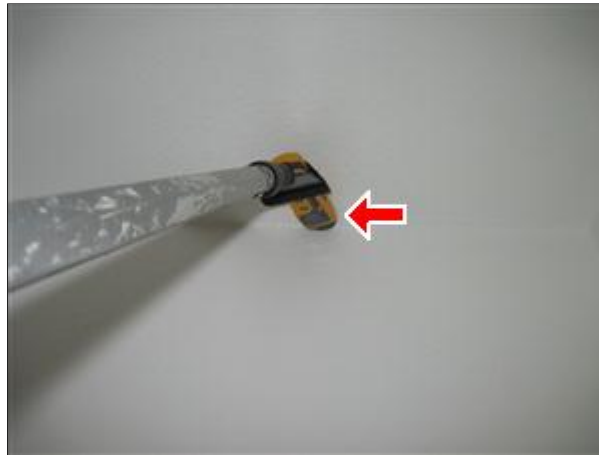
F. Picture 2

(4) Moisture indicators, dark colored spot(s), observed with infrared scan and excessive moisture content was confirmed with moisture meter. Exact source of leak unknown. Suspect roof problem. Repair needed. Locations include but are not limited to: Front bedroom closet ceiling against front wall.

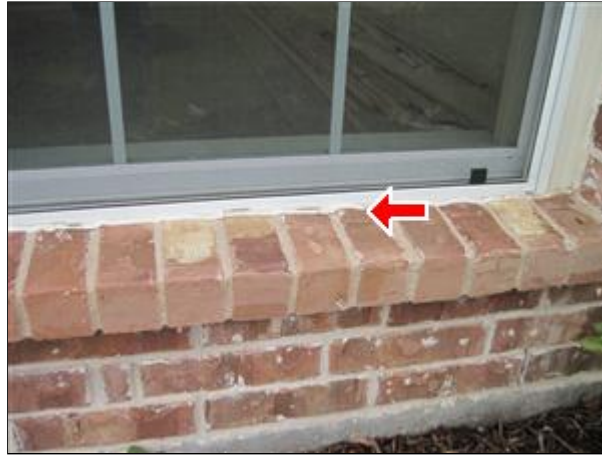
H. Picture 1

(2) Caulking repair is needed at various window exteriors. Caulking incomplete in corners / voids, cracked caulk or missing areas observed. All windows should be checked and improved as needed for optimum efficiency and to prevent possible water intrusion.

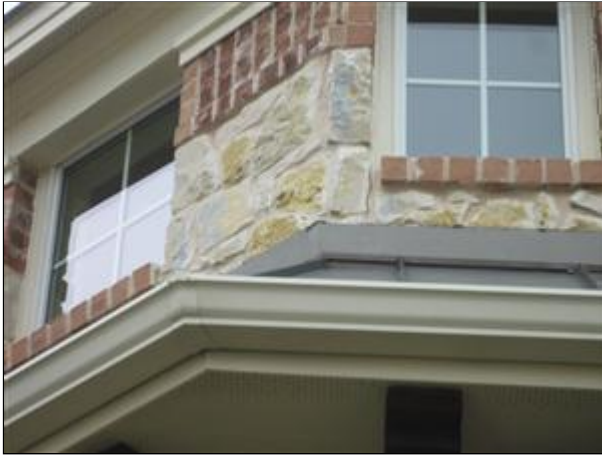
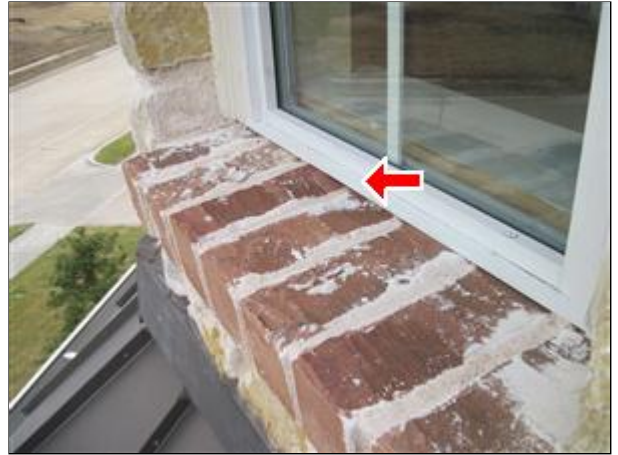
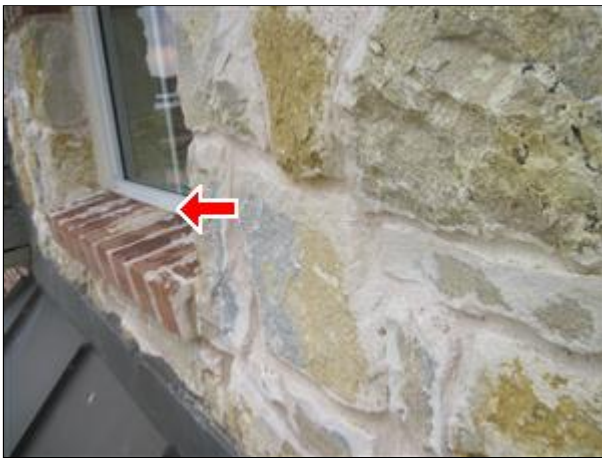
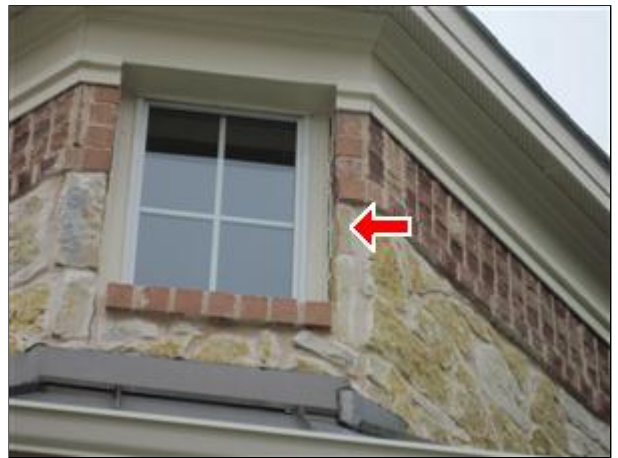
(5) Second story windows above front entry (at upper area of front bedroom) were not completely sealed and sealant was observed to be separating at one side.

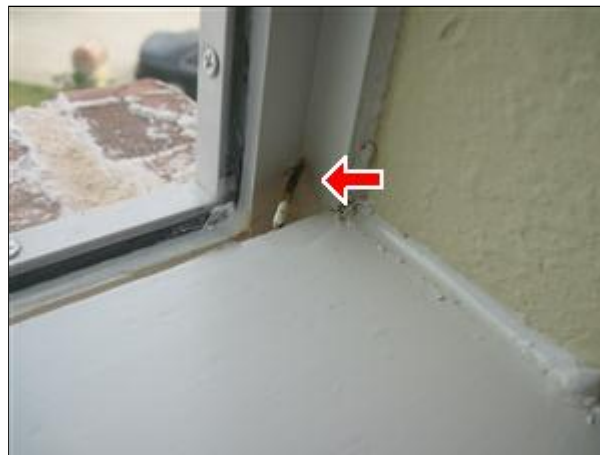
H. Picture 8

(6) Observed nail driven through window frame at window pictured in upstairs front bedroom. Possible moisture entry point. May have ruined the seal of the window. Replacement may be needed. Review and repair or replacement by qualified window contractor recommended.

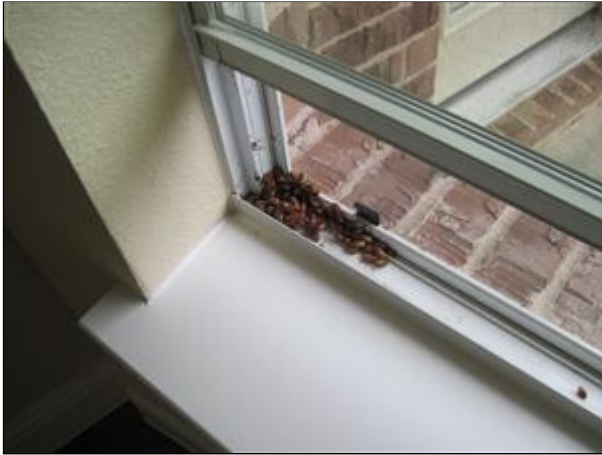
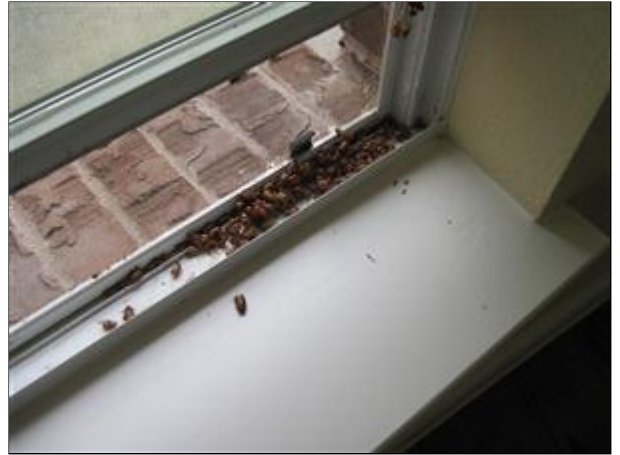
(7) Window frames observed to be full of debris. All window frames should be thoroughly cleaned to allow proper drainage through weepholes.

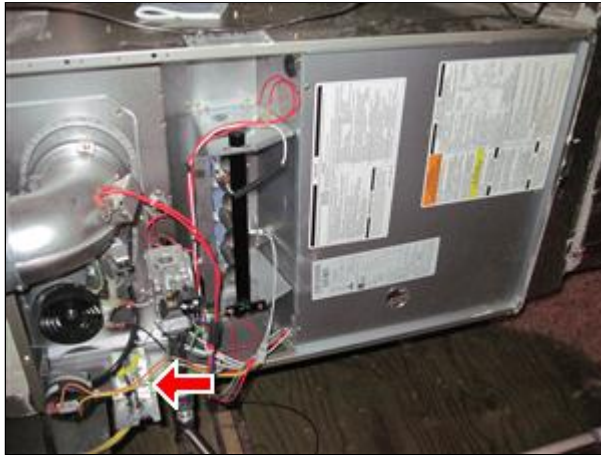
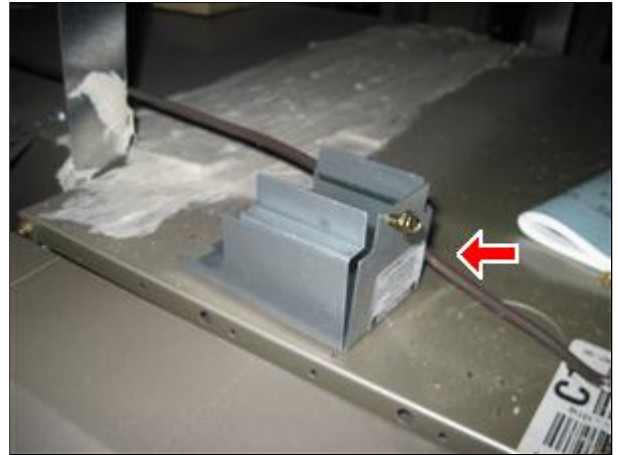
(5) Electrical connections in the furnaces are not properly covered with provided boxes. This does not meet normal manufacturer recommendations and should be improved.

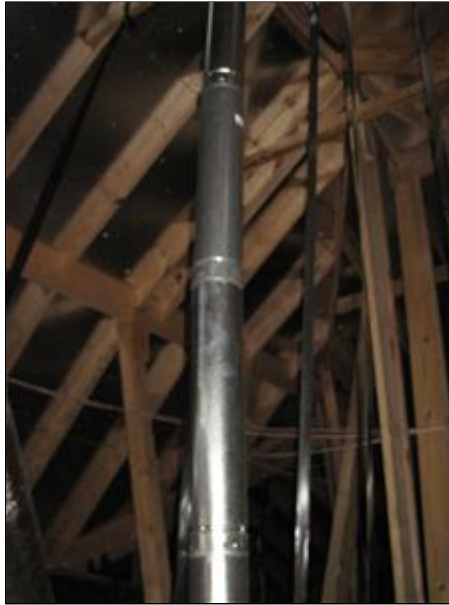
A. Picture 3

(6) West most unit in attic flue is poorly secured. Multiple (6) short sections have been pieced together rather than using longer more secure sections of pipe. Could contribute to the flue become dislodged. Recommend review and repair by qualified HVAC contractor.

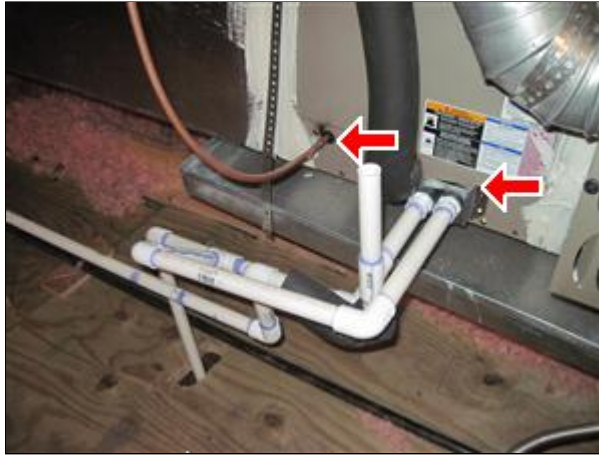
B. Picture 1

(3) Grommets/sealant missing around ac lines and or evaporator compartment openings. Allows air to escape unit and should be replaced/repared to improve efficiency.

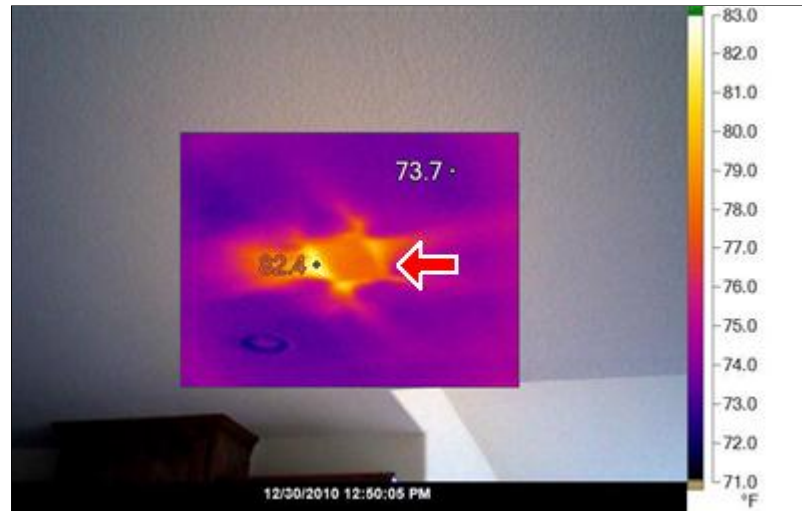
C. Picture 2 Kitchen

Thermal Imaging scan revealed the presence of a supply register box that is not cut out - so no register is installed. Locations include but are not limited to: Kitchen and master closet. While a duct does appear to be connected to the area, not thermal changes were observed that would indicate air supply into the duct. Recommend review and repair as needed by licensed HVAC contractor.

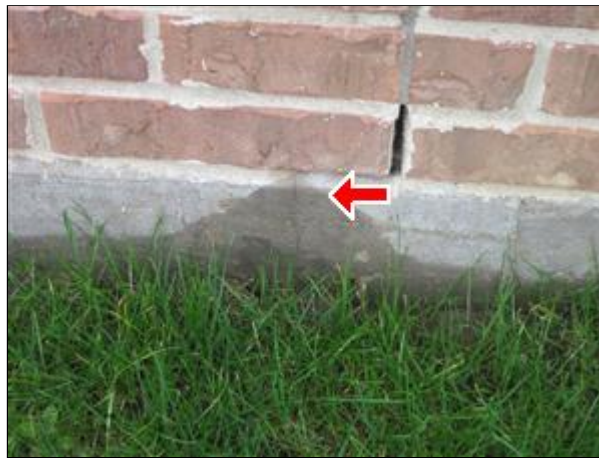
A. Picture 5 Suspected moisture from shower leak.

(1) Active leaks detected in master shower surround area. Infrared Thermal Imaging found active moisture outside of the shower enclosure. Excessive moisture content was confirmed by a moisture meter. Determining the extent, time-frame, or damage caused by leakage is beyond the scope of this inspection. Review and repair by qualified tile expert needed.

Leakage from the shower enclosure indicates improper installation of the moisture barrier under the tile. When properly installed this system will NOT allow moisture to escape the enclosure. Due to the fact that a complete evaluation of the moisture barrier installation is not possible due to it being inaccessible for inspection and the leakage discovered we recommend that the shower enclosure and tile be completely removed and reconstructed.

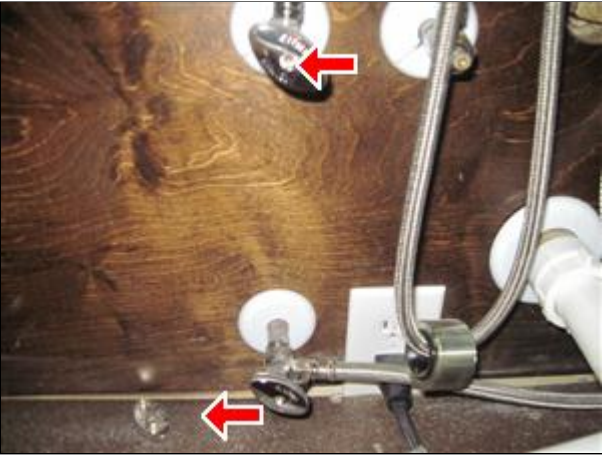
A. Picture 6

(2) Wall valve handles not secured. All fixtures should be checked and repaired as needed.

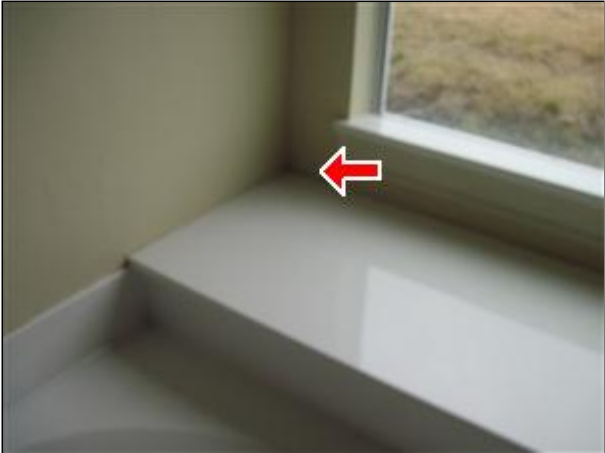
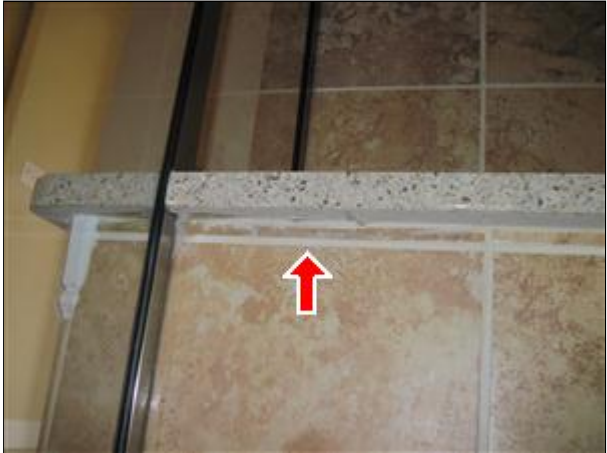
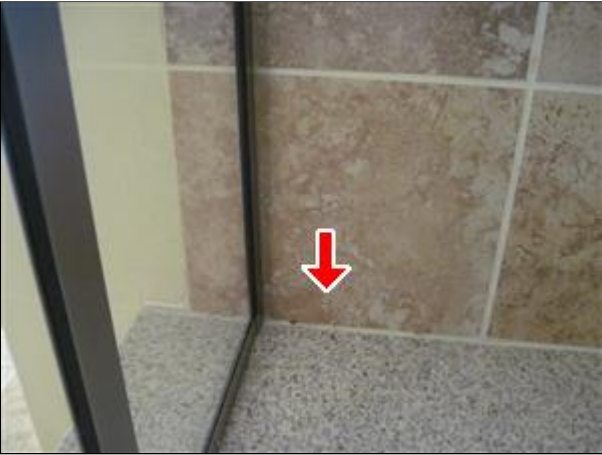
(3) Caulking repair needed at master tub and shower.

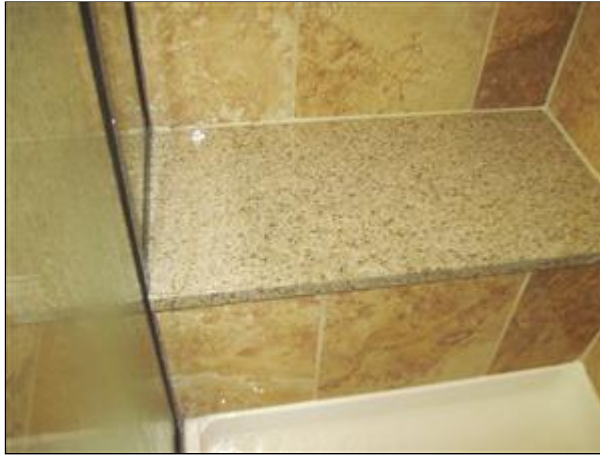
A. Picture 10

(4) Shower seat installed with insufficient / improper slope. There should be a noticeable slope toward the shower pan. Water pooling and standing. Condition can lead to water penetration problems. Recommend repair to correct seat slope.

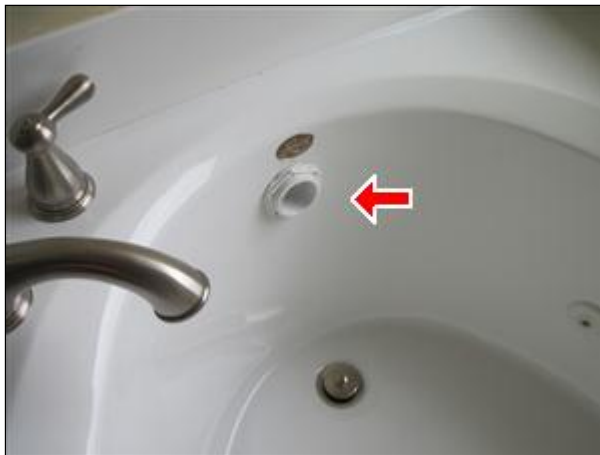
B. Picture 1

(1) Overflow cap missing at master tub.

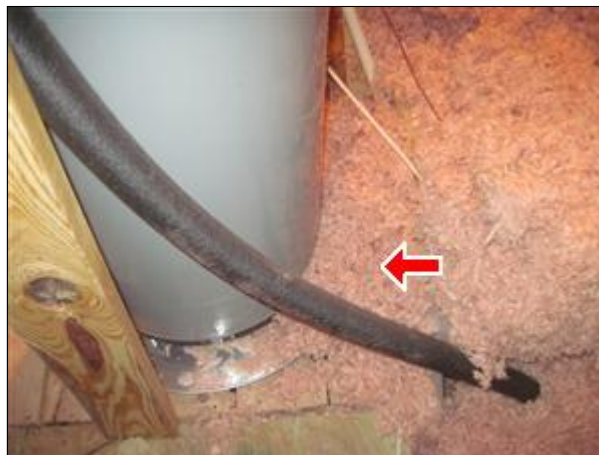
C. Picture 3

(4) Remove insulation and debris from water heater safety pans. Debris or insulation in these pans can lead to premature blockage of the drain line which can result in flooding of the residence in the event of tank failure.

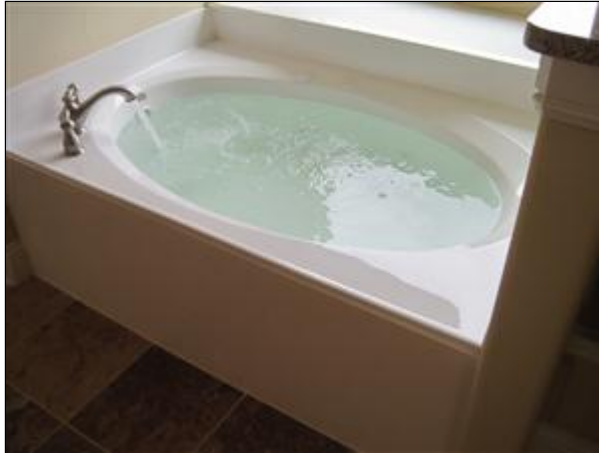
D. Picture 1

(1) Unit did not operate to normal controls. Did not come on.
