Inspection Report

Property Address:
12345 Older Home Sample Report
Dallas TX 75238

Absolute Inspections, LLC

PROPERTY INSPECTION REPORT

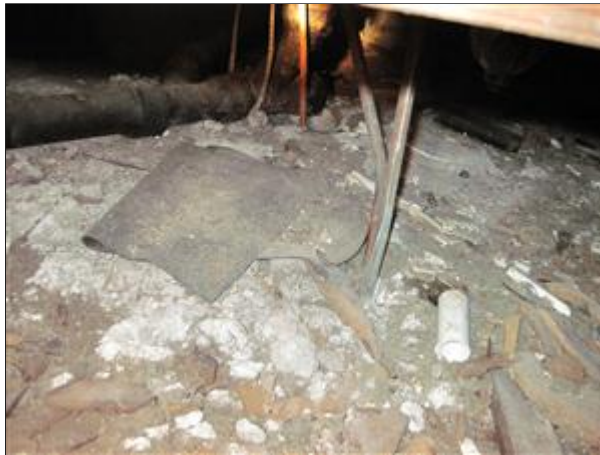
A. Picture 3

(4) Moisture was observed in crawlspace soil near garage entrance at drain plumbing in area pictured. Unable to determine if this moisture is from outside and natural drainage to this low spot or from leakage at drain pipe. Further investigation is needed.

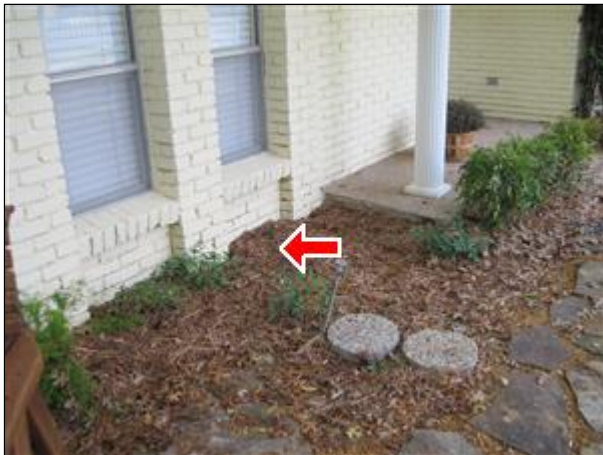
B. Picture 3

(1) There is a negative slope at the front of home and can cause or contribute to water intrusion or deterioration. A surface drain system is in place. The surface drain system was not tested. Some drain catch basin covers observed to be clogged with mud and debris. Recommend cleaning and confirmation of function of this system.

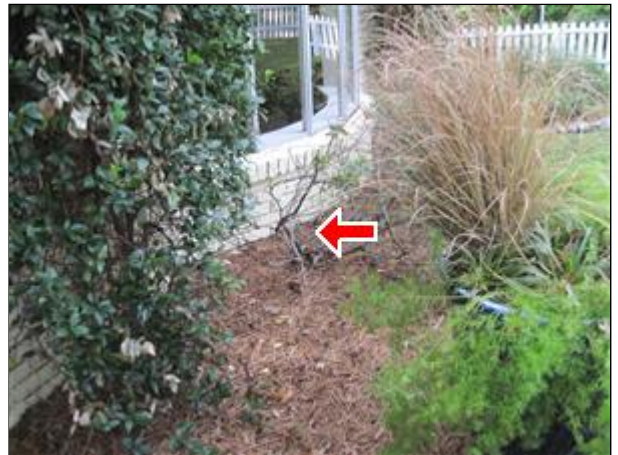
B. Picture 4

(2) Soil level too high at front of home and a East side of garage in rear around the foundation. Ideally there should be a gap of 4 to 6 inches between the soil and the bottom of the brick / top of foundation. Failure to maintain this gap can lead to moisture penetration in wall and is known to be conducive to termite activity. Recommend modifications to achieve and maintain this spacing.

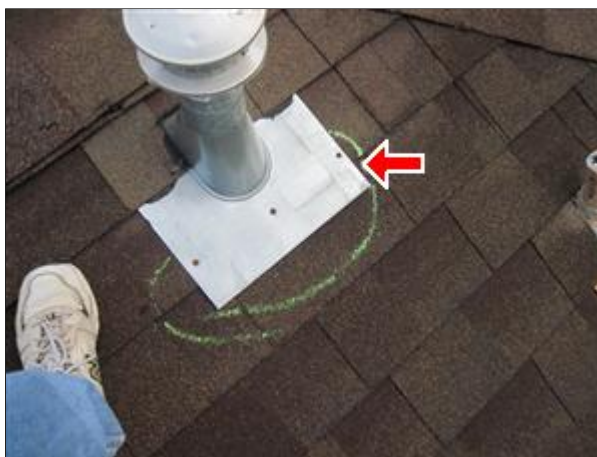
C. Picture 1

(2) Exposed staples / nail heads / fasteners observed on roof, all exposed fasteners should be sealed with appropriate roofing sealant to prevent water entry. The entire roof surface should be checked and repaired as needed at time of repair.

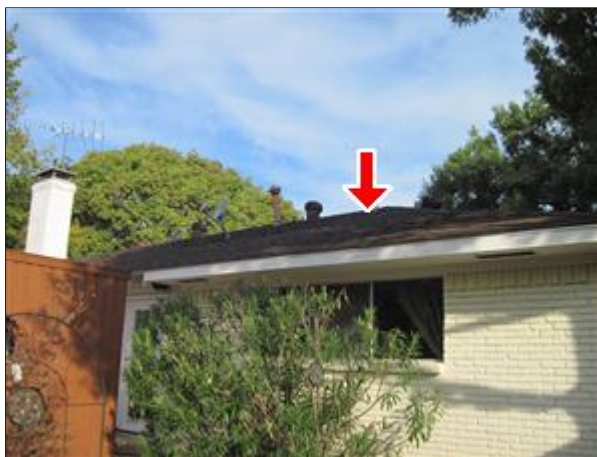
C. Picture 2

(3) Visible deflection, which could be considered excessive (a subjective opinion), observed in roof decking at rear of home. Proper structural support and decking/underlayment/shingle installation should be confirmed in writing or areas repaired as needed.

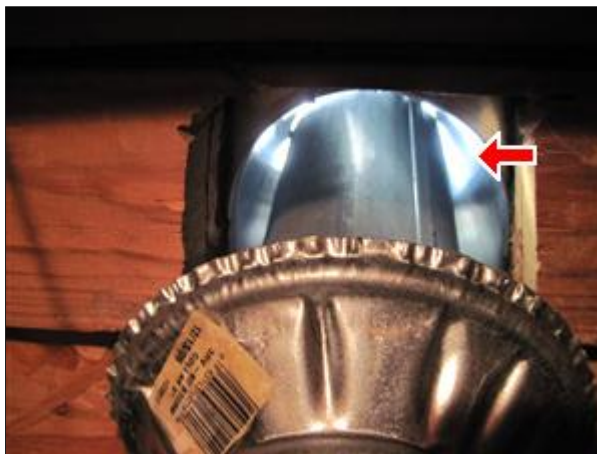
C. Picture 3

(4) Observed light gaps at water heater vent penetration(s) from attic. Recommend addition of approved sealant material from the roof side to prevent possible moisture intrusion into attic.

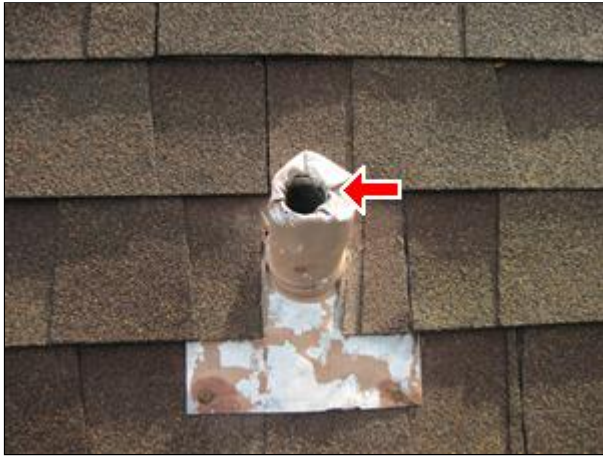
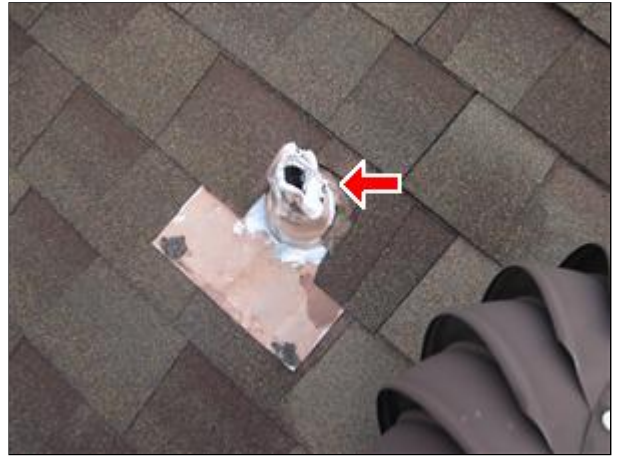
(5) The plumbing vent pipes need caulking around the perimeter of pipe and boot where boot flange has failed.

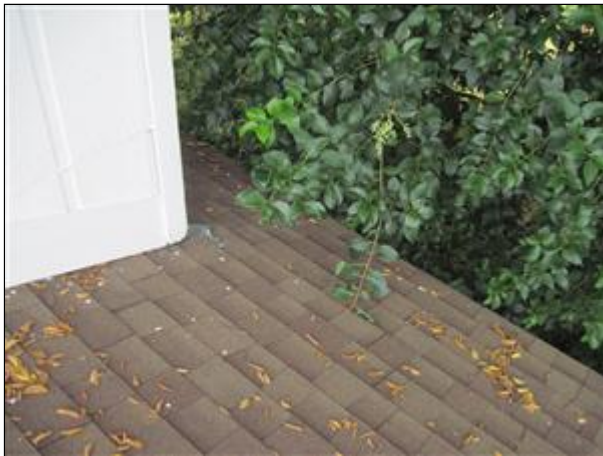
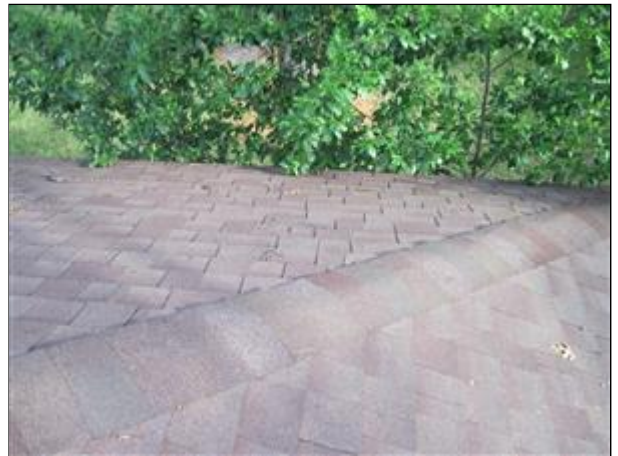
(6) The tree limbs that are in contact with roof or hanging near roof should be trimmed.

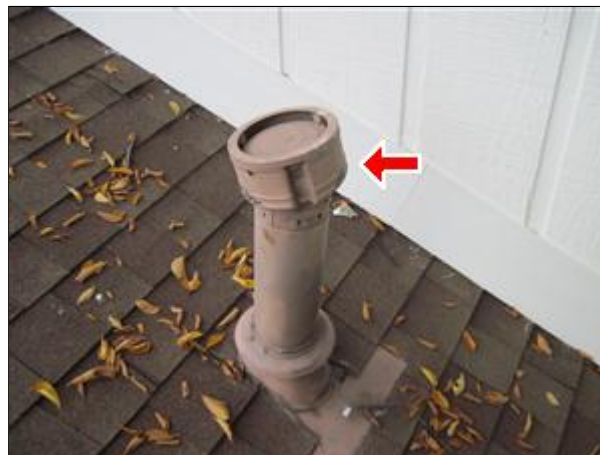
C. Picture 8

(7) Vent cap pictured is loose and askew.

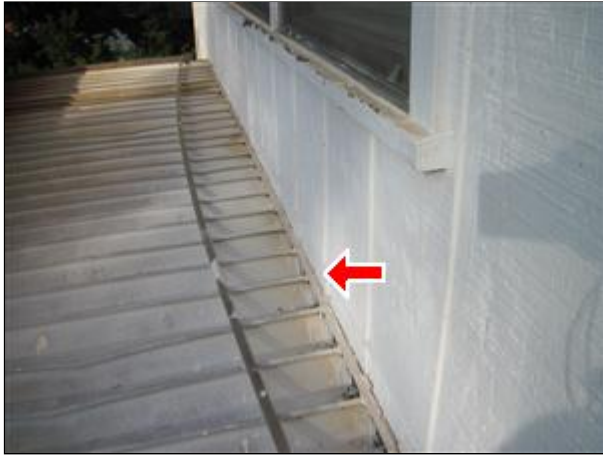
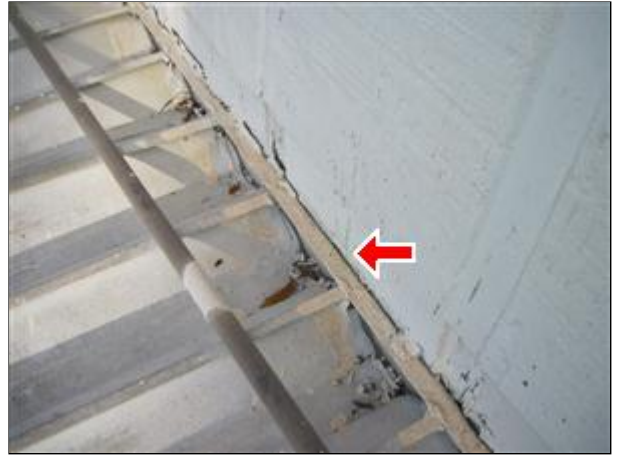
(8) Sealing needed at roof / deck connection with siding above garage.

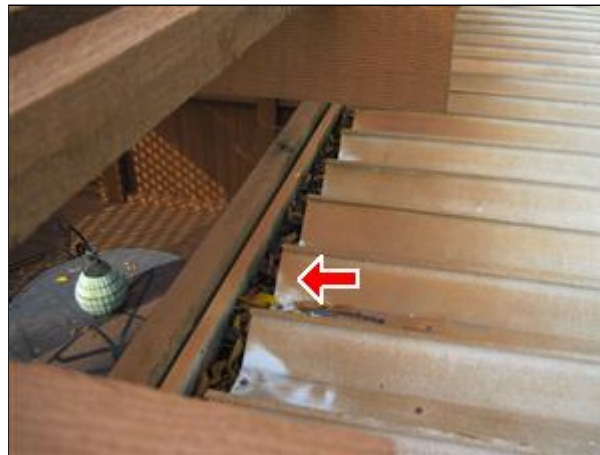
C. Picture 11

(9) Roof section above driveway deck full of leaves and debris. Possibly contributing to moisture penetration below. Maintenance needed.

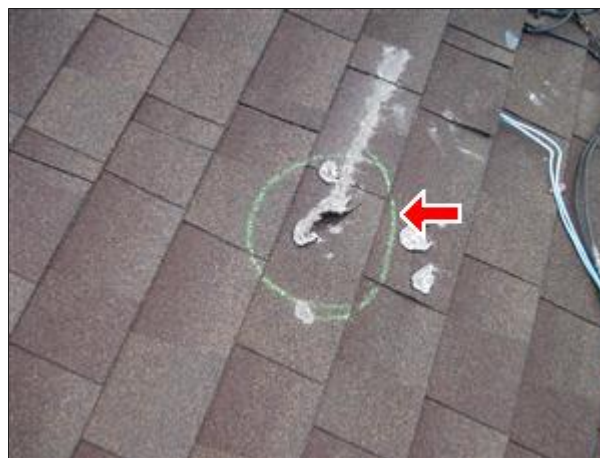
C. Picture 12

(10) Damaged / Pitted / Cracked shingles observed on roof. Cause of damage not determined. Recommend immediate review of shingles by qualified roofing contractor. Entire roof surface should be examined and repaired as needed at that time.

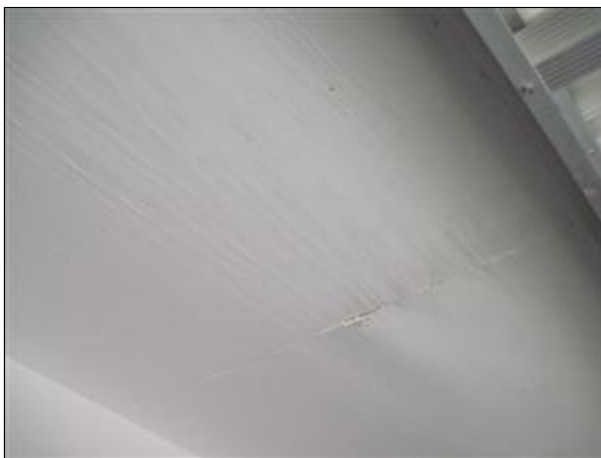
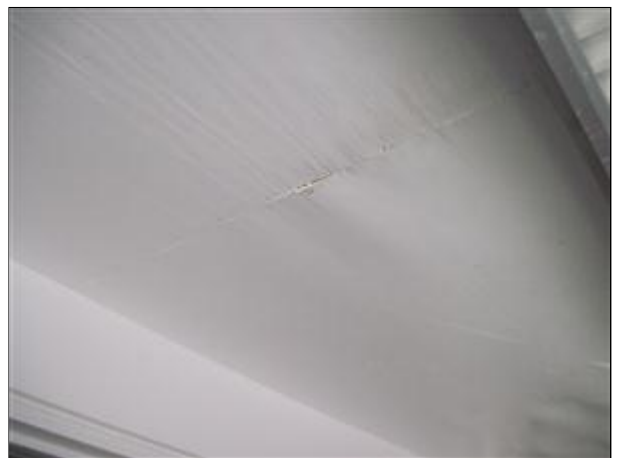
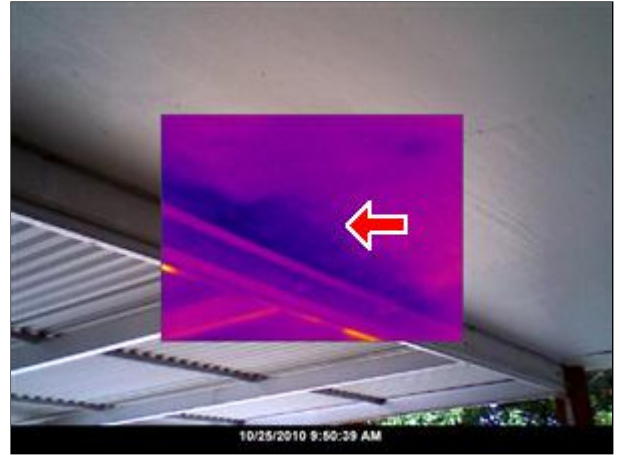
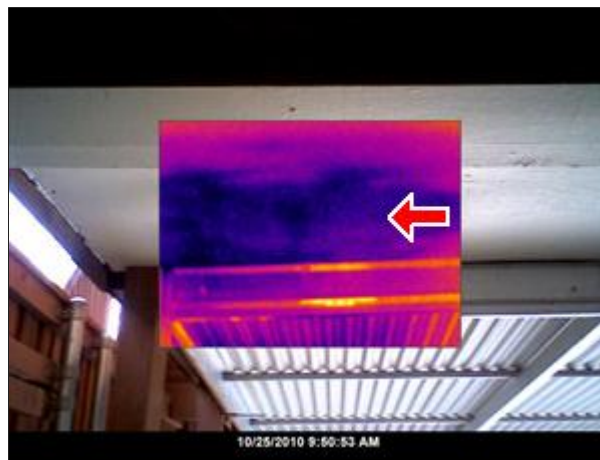
(1) Paint repair needed at soffit and fascia in various self evident locations around the home.

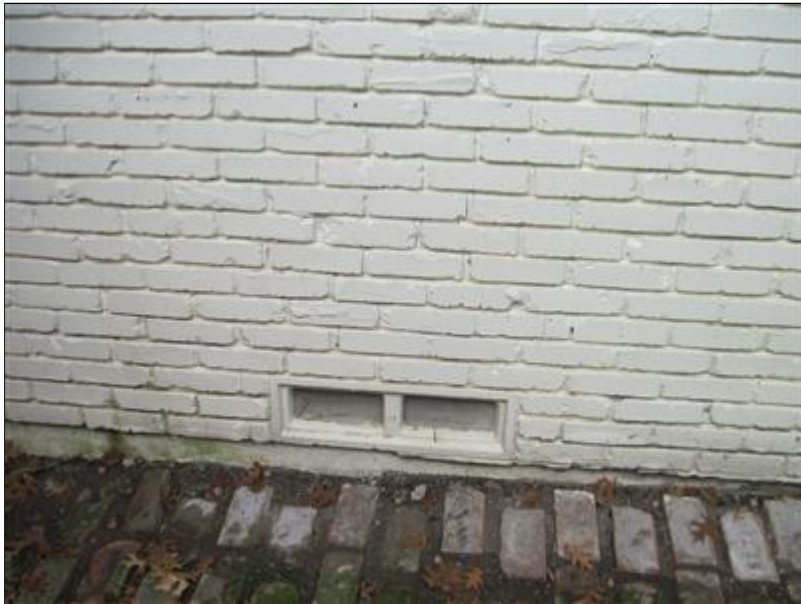
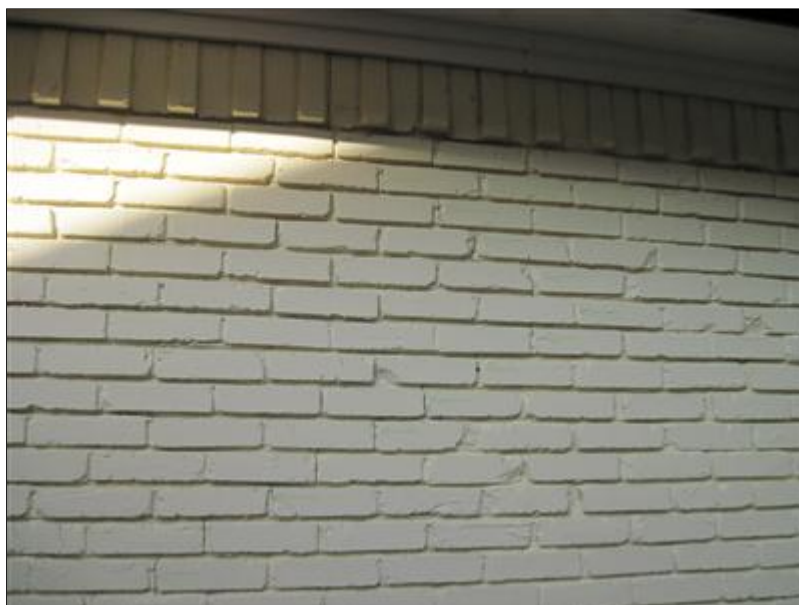
(1) Observed area(s) of the brick veneer where the brick is overhanging the foundation by greater than 1/3 the width of the brick. This installation is generally not acceptable according to typical brick manufacturer guidelines. Repair options are limited. Locations include but are not limited to: (East side of home)

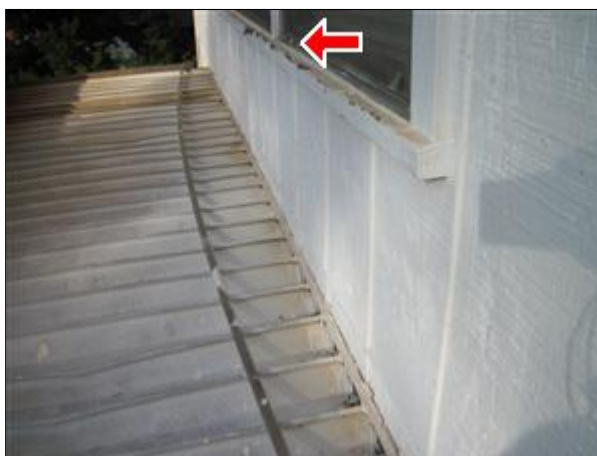
E. Picture 7

(4) Siding rot observed on North side of second story addition. Other areas may exist and be found at time of repair.

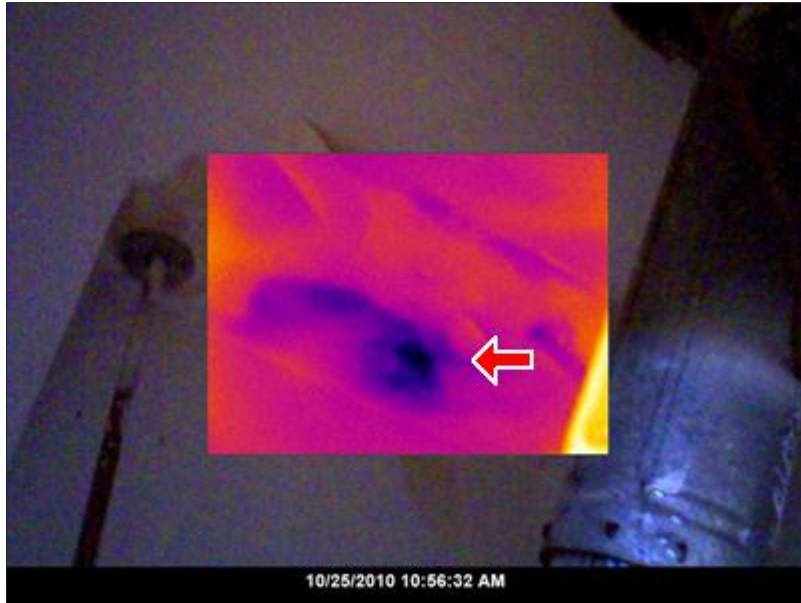
F. Picture 1

Moisture indicators, dark colored spot(s), observed with infrared scan and excessive moisture content was confirmed with moisture meter. Exact source of leak unknown. Suspect roof problem. Repair needed. ***We strongly recommend that testing, by a state licensed mold inspector, be completed to confirm no health risk due to organic growth before commencement of any repair work.*** Locations include but are not limited to: West water heater closet ceiling

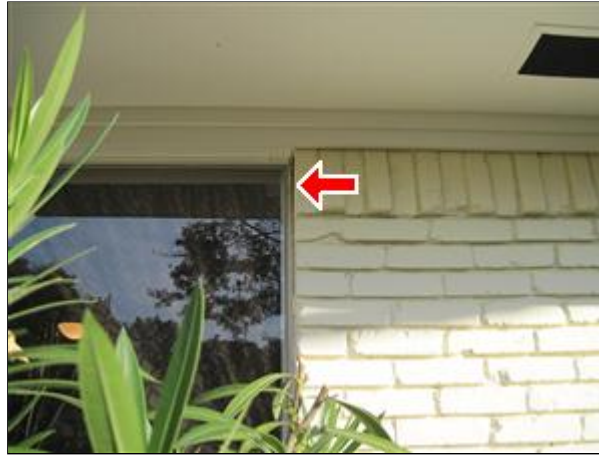
H. Picture 1

(2) Caulking repair is needed at various window exteriors. Caulking incomplete in corners / voids, cracked caulk or missing areas observed. All windows should be checked and improved as needed for optimum efficiency and to prevent possible water intrusion.

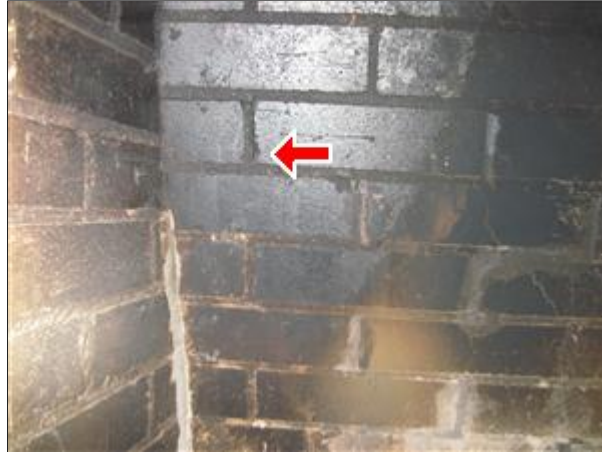
J. Picture 1

(3) Creosote buildup was observed in the portion of the chimney observed from the firebox. Recommend a thorough professional cleaning of the chimney.

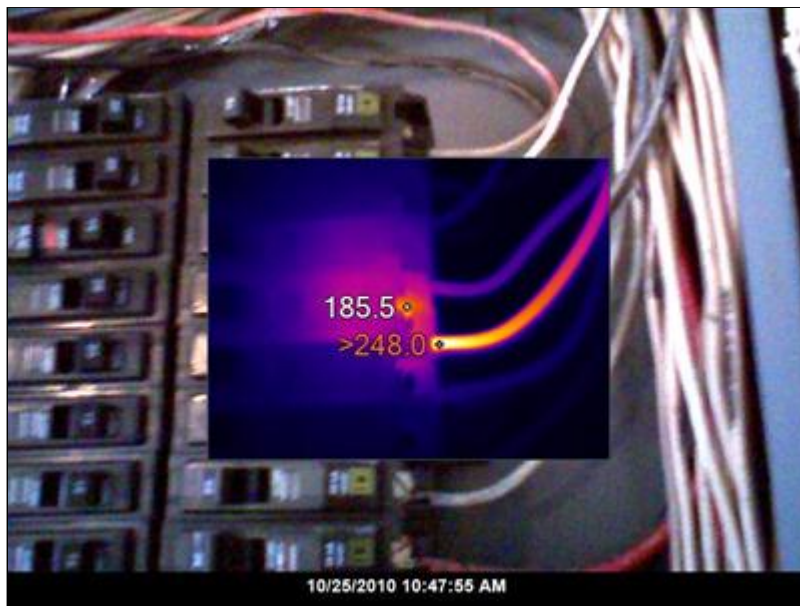
A. Picture 1

(1) Infrared Imaging revealed dangerously hot breaker in panel - high temperature reading exceeded 248 degrees F. Safety Fire Hazard. Inspector turned off breaker and informed the listing agent of the danger and action. Breaker was labeled "breakfast nook outlets." Labeling accuracy is questionable as further inspection revealed this breaker services the living room fan, main attic light and main attic air handler. Immediate review by a licensed electrician is needed for safety.

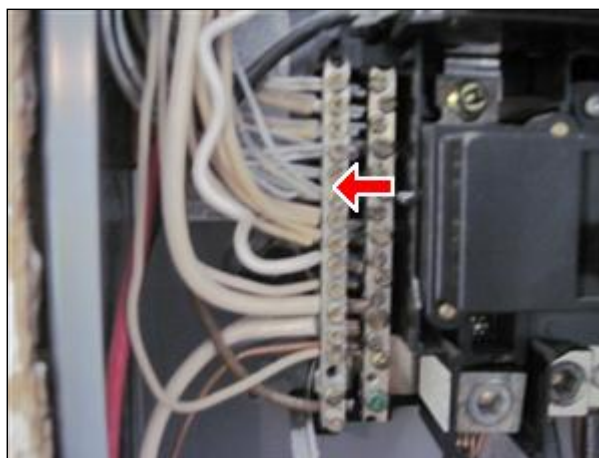
A. Picture 7

(4) There are several double/triple lugged neutral wires in the garage electrical distribution panel (subpanel) that do not meet modern installation requirements. Some jurisdictions permit this wiring

method, others don't. This can be a safety or equipment hazard under certain conditions and I recommend a licensed electrician further inspect and repair if deemed necessary.

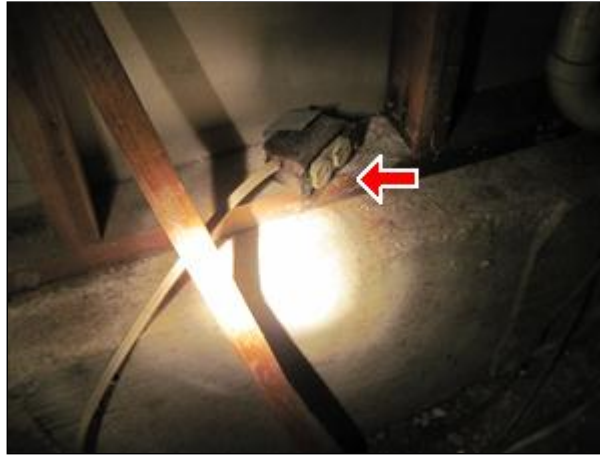
B. Picture 1

(8) Missing cover observed at outlet pictured in crawlspace.

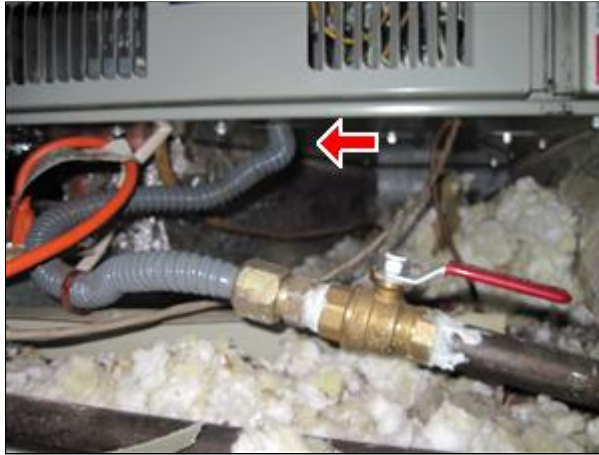
A. Picture 2

(5) Gas supply flex line(s) was/were routed into the cabinet(s). Current standards require that this connection be made outside of the furnace cabinet. Recommend repair by a licensed HVAC contractor.

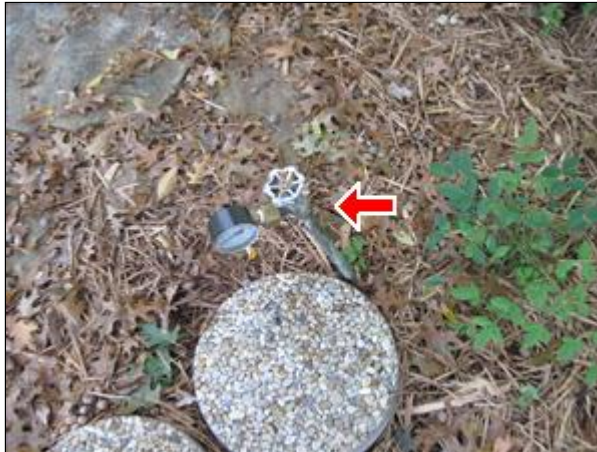
A. Picture 1

(2) Front exterior faucet leaking at packing nut.

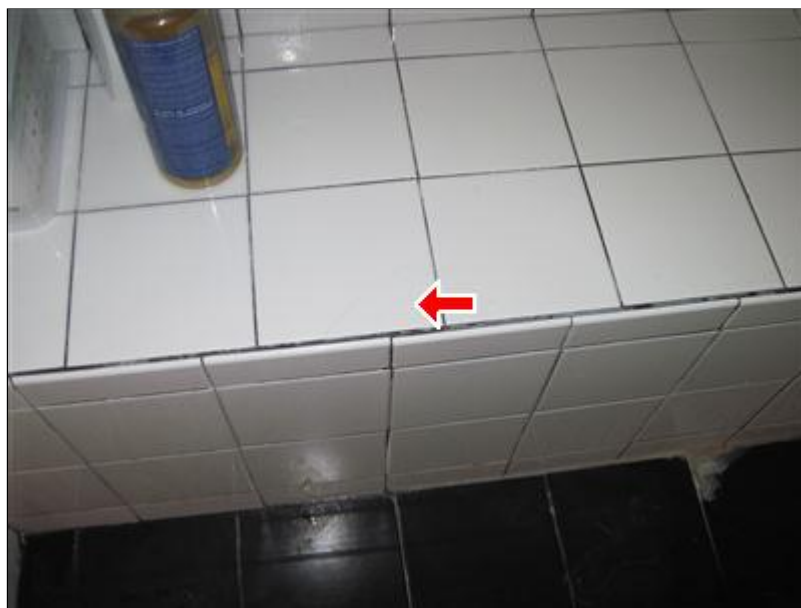
A. Picture 2

(3) Crack observed in tile at master shower seat.

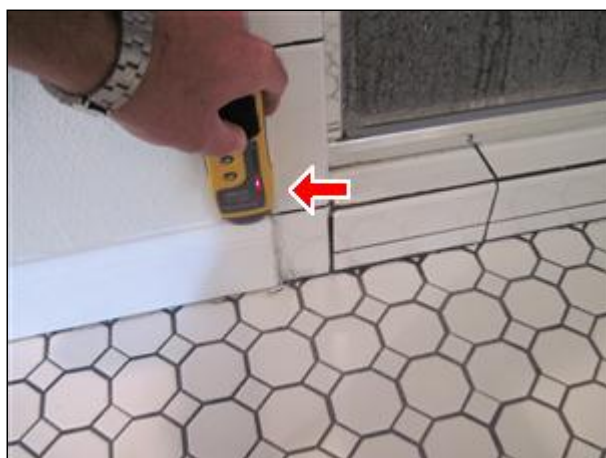
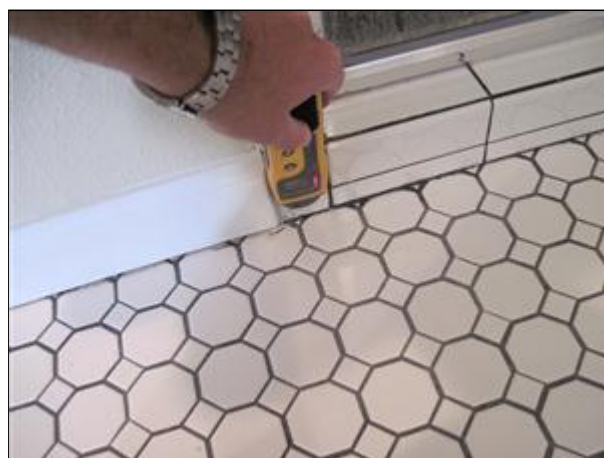
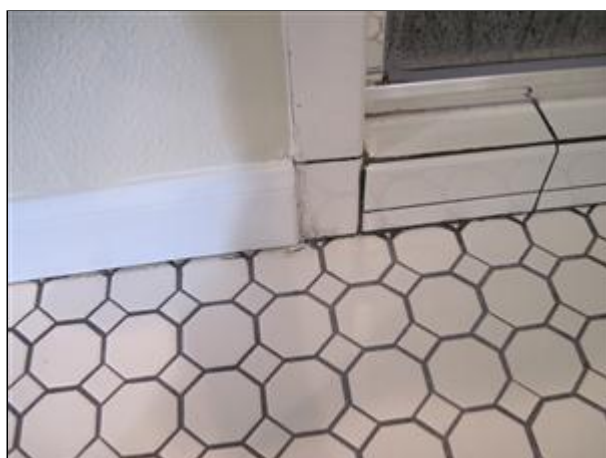
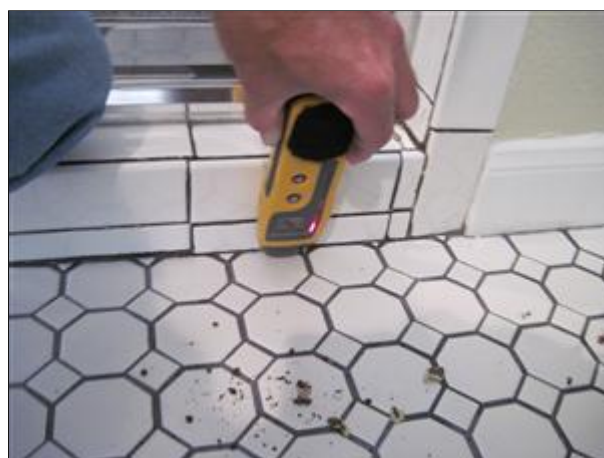
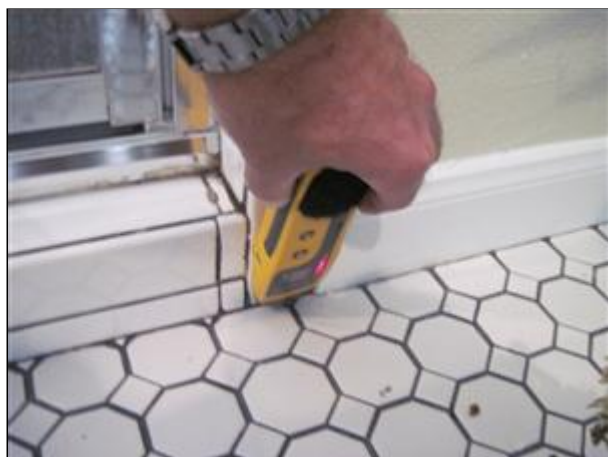
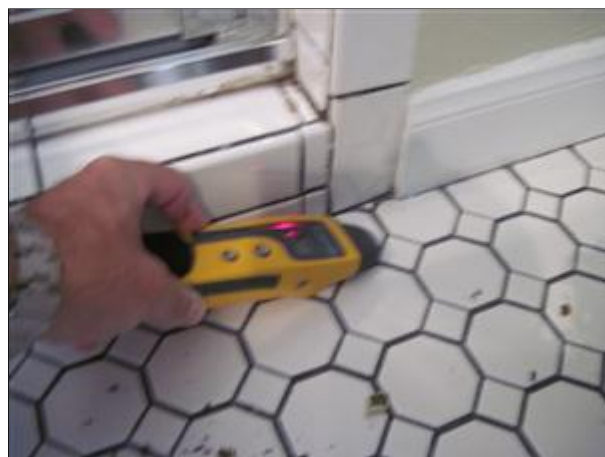
(4) Active leaks detected in master shower area. Infrared Thermal Imaging found active moisture outside of the shower enclosure. Excessive moisture content was confirmed by a moisture meter both at bathroom walls and underneath in crawlspace at floor boards. Determining the extent, time-frame, or damage caused by leakage is beyond the scope of this inspection. Review and repair by qualified tile expert needed. **We strongly recommend that testing, by a state licensed mold inspector, be completed to confirm no health risk due to organic growth before commencement of any repair work.** Recommend complete removal, evaluation, and remediation by licensed specialist, as needed based on licensed mold inspector's findings. The whole process should be supervised by this specialist with appropriate testing completed before and after remediation is completed. After all testing and repair work has been completed, you should be provided written documentation certifying the quality of repair and the fact that the area is moisture free and no potential health hazards from organic growth are present.

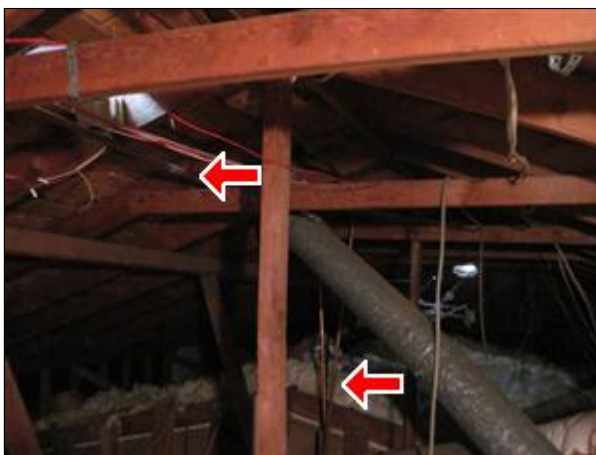
A. Picture 14

(7) Uninsulated copper pipe was observed in main attic above the master bathroom. Freeze / leak danger.

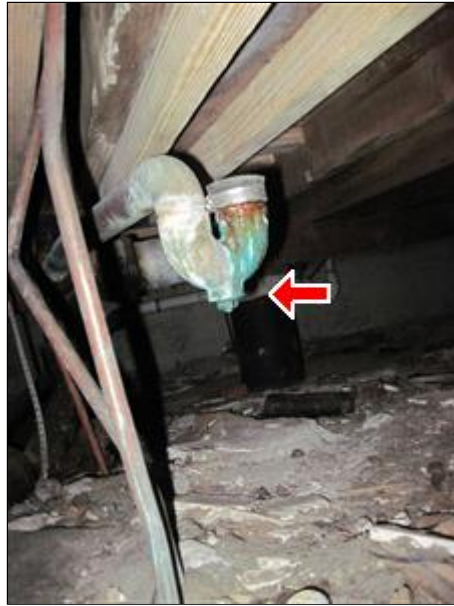
B. Picture 1

(1) Active leakage observed in crawlspace at vanity drain plumbing. Repair needed.

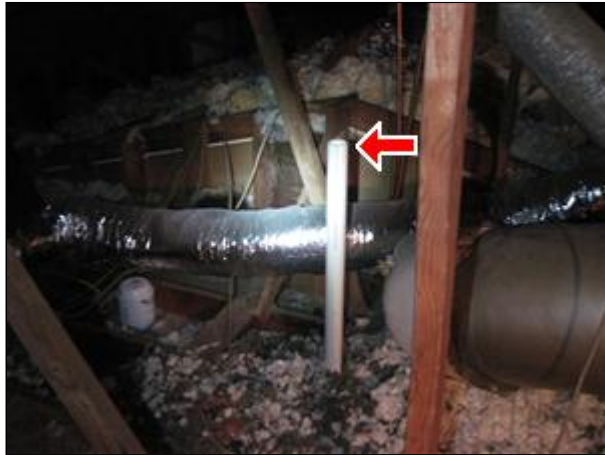
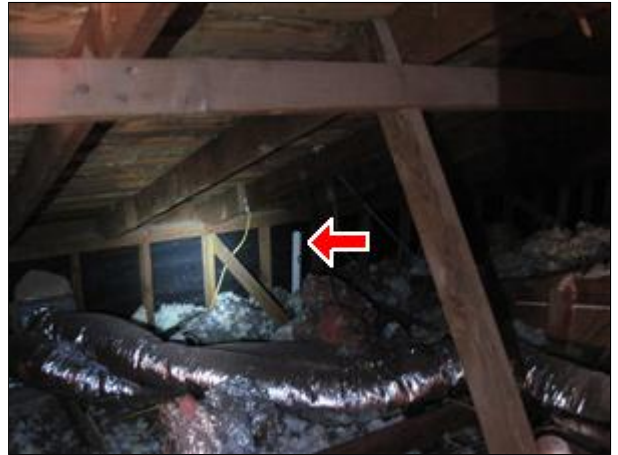
(2) Observed PVC pipe that appears to be drain plumbing vents for remodeled master bathroom terminating in the attic. Improper installation. Could lead to sewer gas buildup in attic. Recommend review and repair as needed by qualified contractor. Brings into question the quality of the plumbing work of the remodeler and whether or not proper permits and inspections were obtained. You may wish to inquire with the city to establish that all is in order in this area.

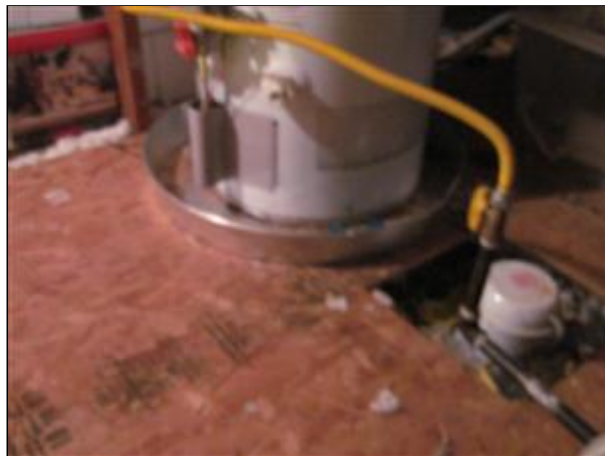
C. Picture 5 Unit not properly supported for attic installation

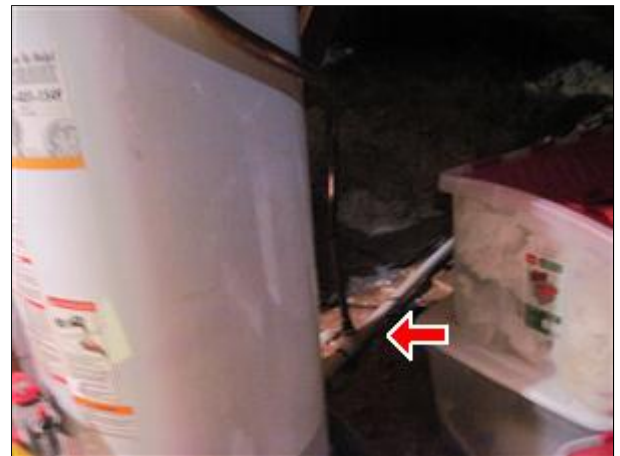
C. Picture 6 TPR tied to pan drain

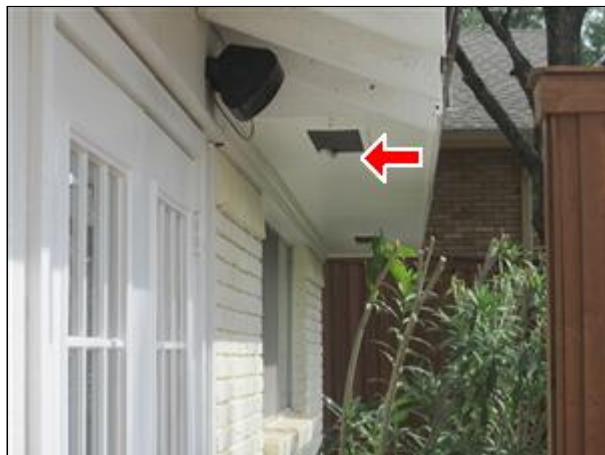
C. Picture 7 Pan drain termination point improper

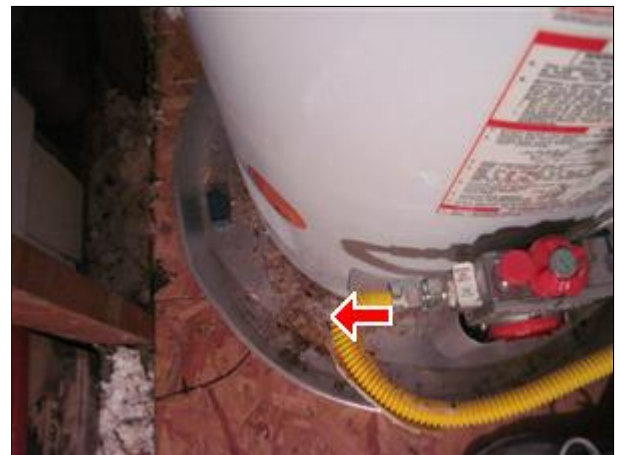
C. Picture 8 Debris in pan
