Inspection Report

9876 One Year Builder Warranty Inspection Road
Plano TX 75024

PROPERTY INSPECTION REPORT

By: Kevin R. Weiss / Absolute Inspections, LLC 1/16/2011

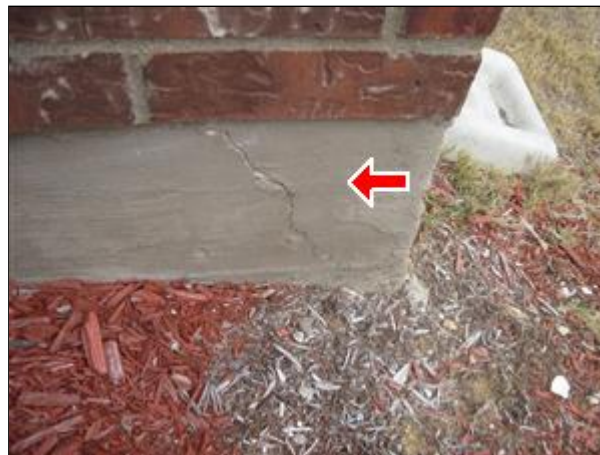
A. Picture 1

(3) "Corner Popping" was observed at some corners of the foundation. "Corner Popping" is usually not a structural concern. It is a condition where the corner of the foundation cracks and sometimes falls away. We recommend that all "popping" corners be repaired or patched to prevent further deterioration or

possible pest intrusion through the cracks. After repairs have been completed you should monitor these areas for signs of excessive movement and consult with a structural expert in the event such is observed.

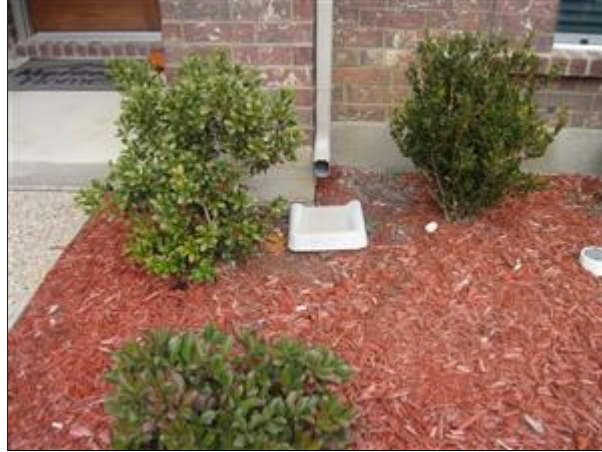
B. Picture 1

(1) Construction and industry standards recommend gutters terminate five feet from the foundation edge, especially in areas where excessive clay soils are prevalent, in order to prevent excessive water from accumulating near the foundation. Excessive water near the foundation can cause foundation related problems. Above ground downspout extensions can make yard care difficult and are often removed by the homeowner, but are functionally acceptable. Below ground extensions are available and should be considered. The absence of extensions may prove acceptable in as long as adequate slope away from the home and splash blocks are provided, but is not recommended. Monitor this condition over time and make corrective action or repair as needed.

(2) Home is only partially equipped with gutters. We recommend full guttering to manage roof water runoff with the expansive soils in our area. When installed you should make sure that all downspouts extend away from the foundation at least 3 feet. I recommend considering an underground extension, as it is least obtrusive.

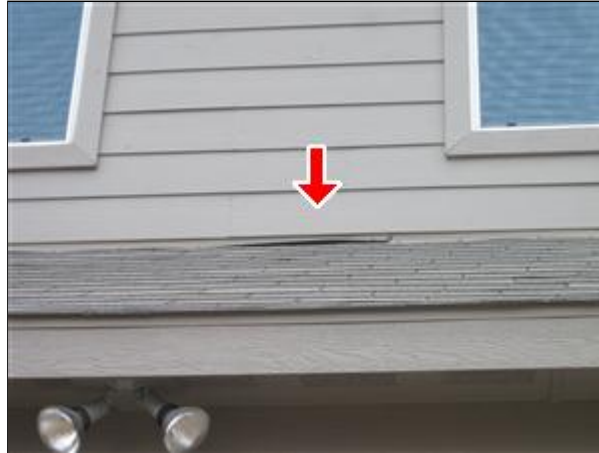
C. Picture 7

(2) Flashing was observed to be lifted and/or not properly secured. This condition could allow water penetration. Repair by a qualified roofing contractor needed. Locations include but are not limited to: Pictured

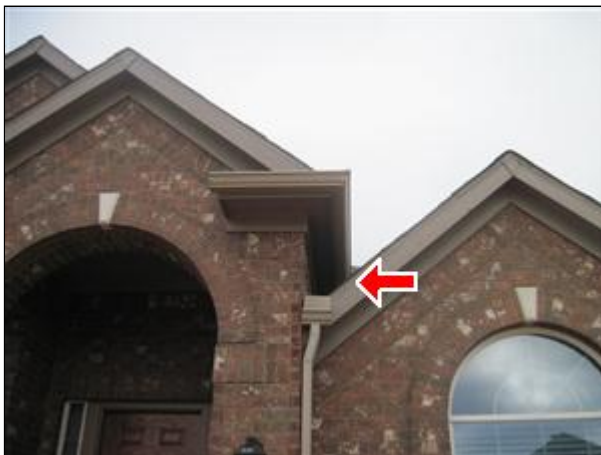
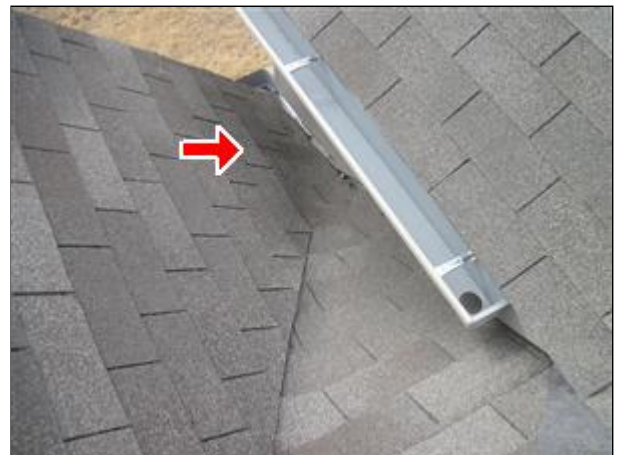
(1) Area of roof structure pictured is by design conducive and prone to leakage. Roof design routes a large amount of roof water to the valley created by the vertical wall. Deterioration / or inadequate

installation of caulking and or flashing can lead to leakage. These areas should be monitored regularly and maintained as needed

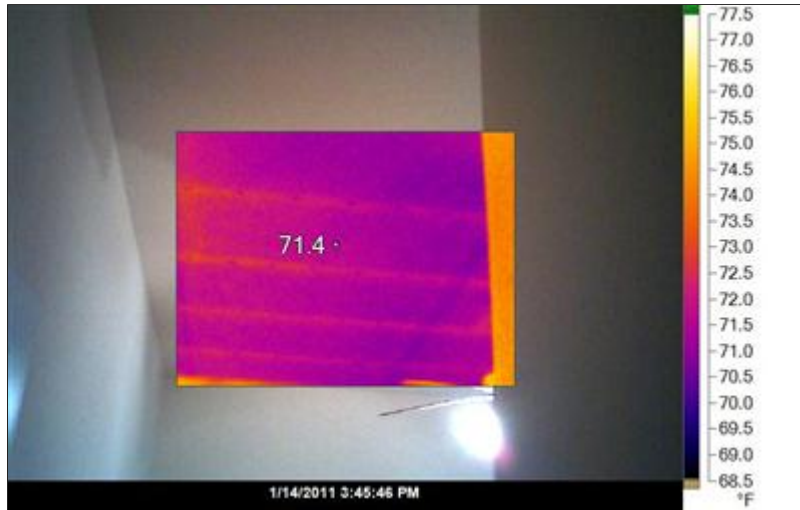
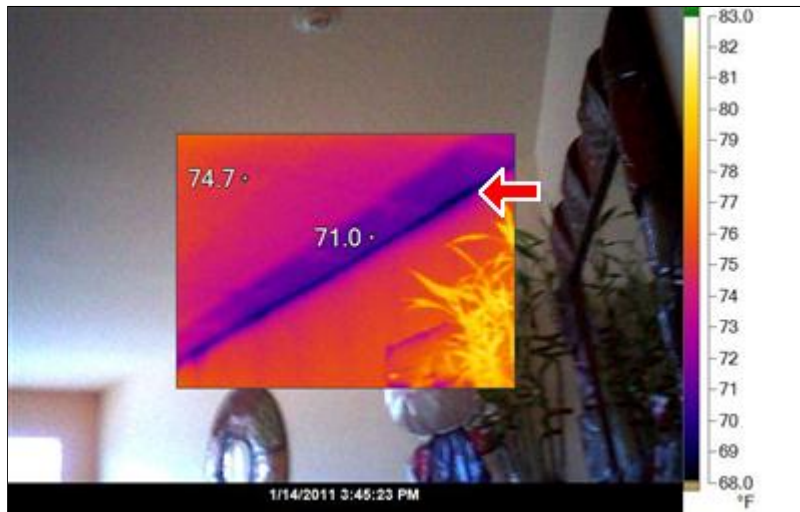
D. Picture 3 Infrared Imaging shows no insulation

(2) Infrared Imaging reveals that the rear guest bedroom ceiling is completely missing insulation and one small section of the living room ceiling is missing insulation. This attic area is inaccessible for visual inspection. This lack of insulation has caused multiple efficiency issues while the home has been occupied. Insulation of the living areas, ie the building envelope, is mandatory and crucial to the efficiency and comfort of the home.

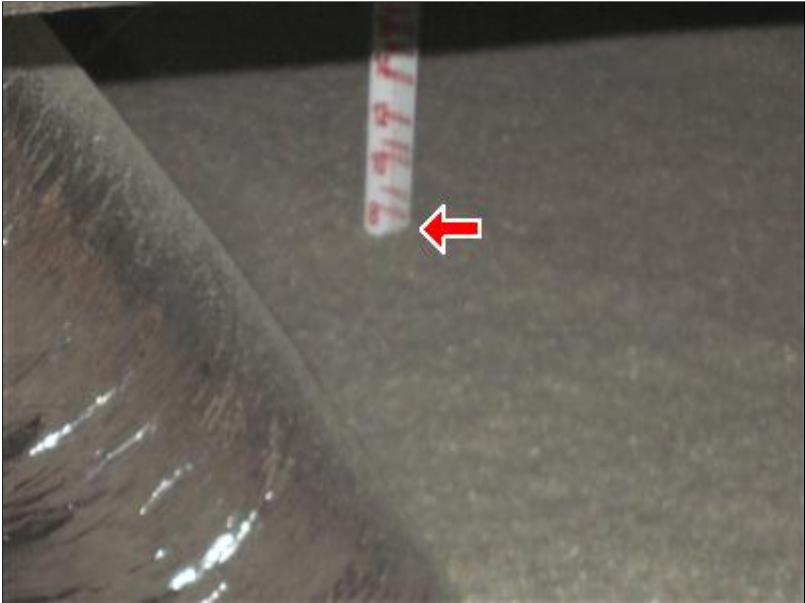
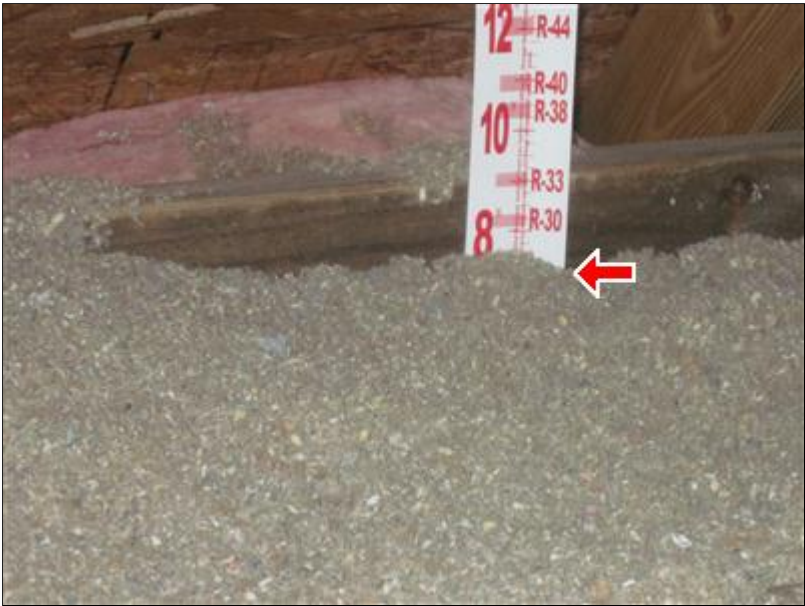
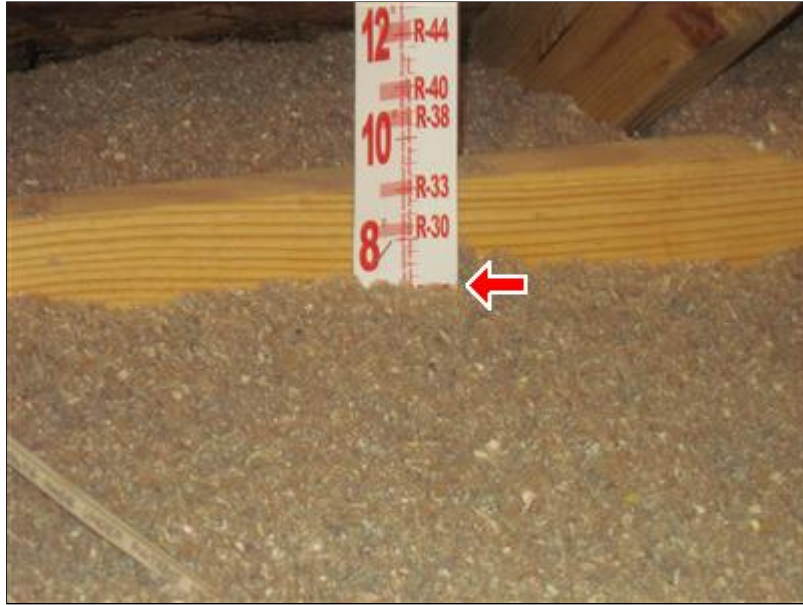
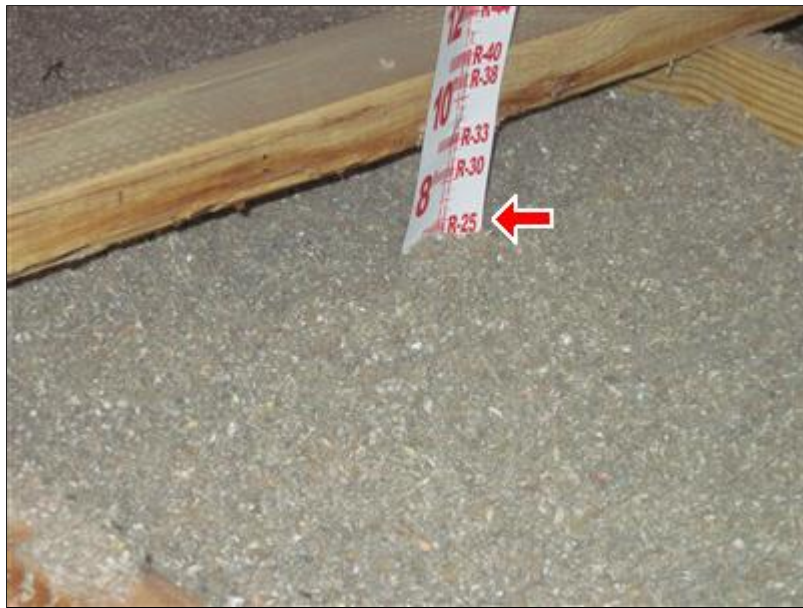
(3) Some areas observed to have less than required R-30 minimum insulation level due to uneven installation. Insulation level at markers observed to be high points and some were still below recommended levels. Recommend having installer add additional insulation to bring the level to a constant level of at least R-30.

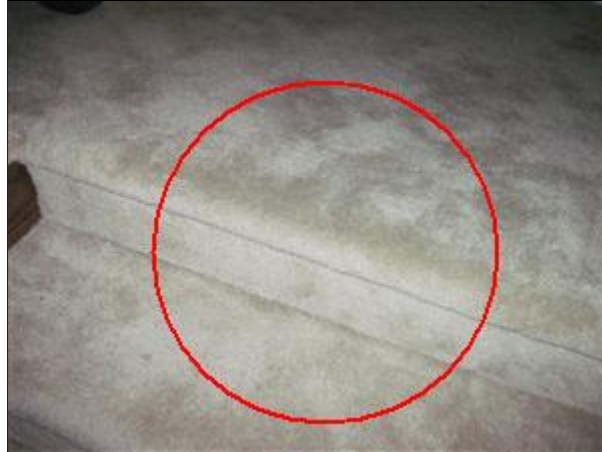
F. Picture 1

Loose and squeaking floor boards found on 2nd floor. This can indicate that the floor decking was not properly secured to the joists. Recommend repair by qualified contractor.

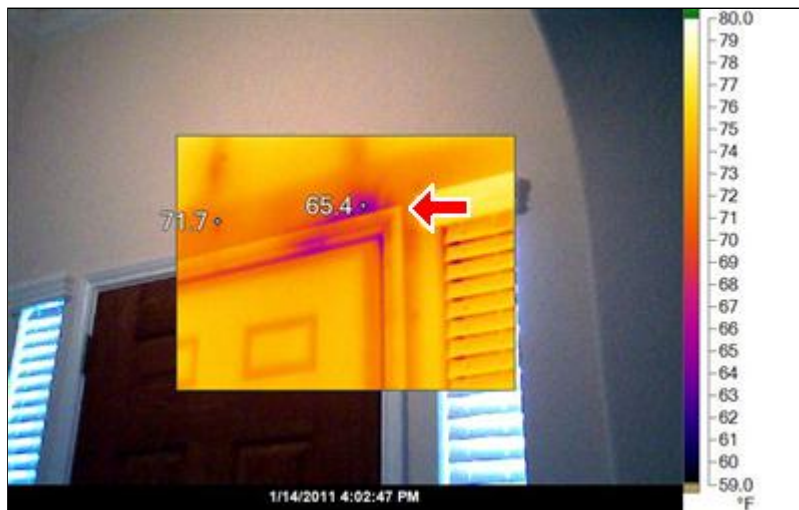
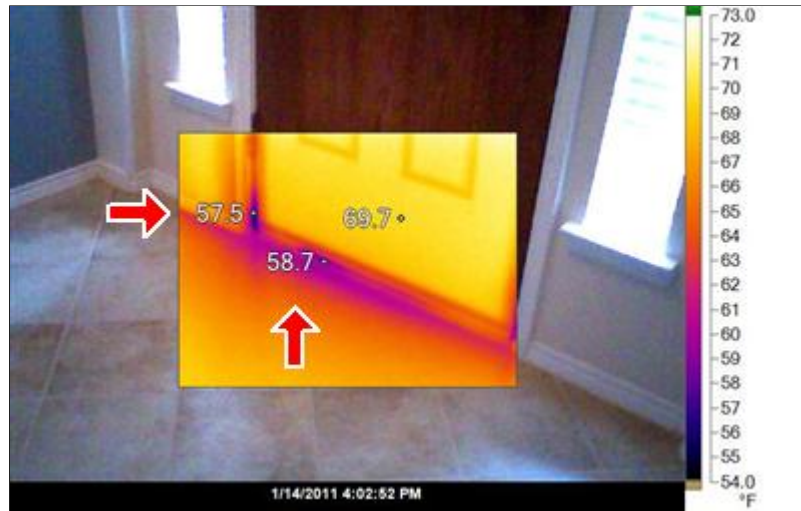
(2) Infrared imaging revealed air infiltration at doors to attics/exterior/garage. Cold air flow is indicated by the dark area above/around door, door frame, and/or trim. Recommend sealing between door frame and building frame eliminate to gaps and / or improving the weather-stripping of the door to improve efficiency.

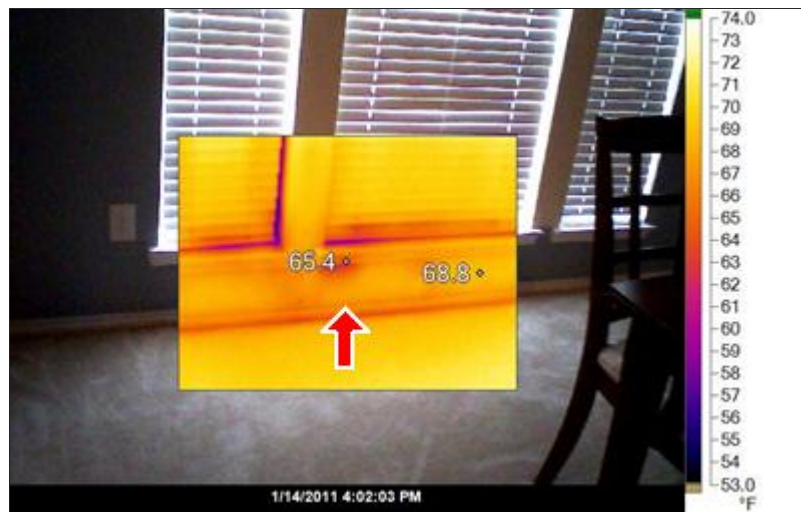
H. Picture 1

(2) Windows were observed that did not close properly and would not latch. This is a security hazard and an efficiency concern. Repair can requires replacement/reinstallation of the window if the window was installed improperly or out of square. When properly installed the window should latch easily and completely. Recommend review and repair as needed by a qualified window contractor.

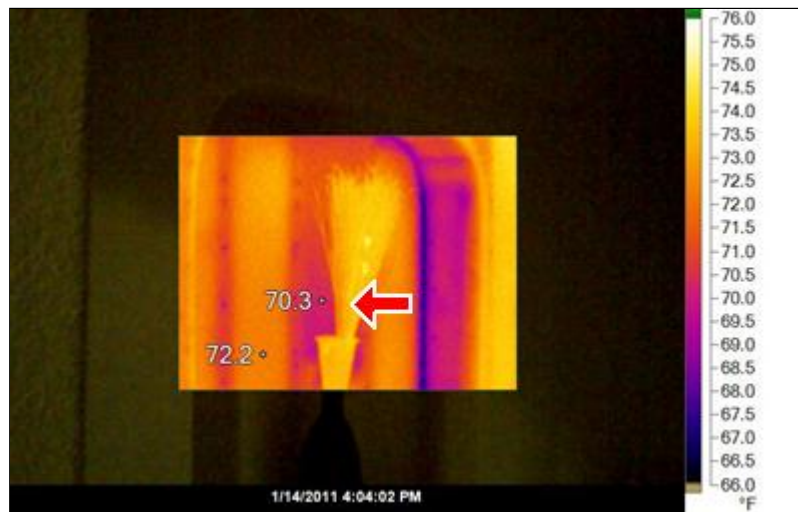
L. Picture 1

(1) Thermal anomalies, indicative of missing or improperly installed insulation (in many cases the insulation is present and falling out or improperly installed between the studs), were observed during the Infrared scan of the home. These anomalies show up as the darker colored areas between the studs in the infrared pictures. Improvement of the insulation in these areas could improve your energy efficiency and costs. Generally speaking, any repairs that can be conducted from the attic should be completed, repairs that require removal and replacement of sheetrock should be carefully considered (benefits versus potential cosmetic concerns) before work begins.

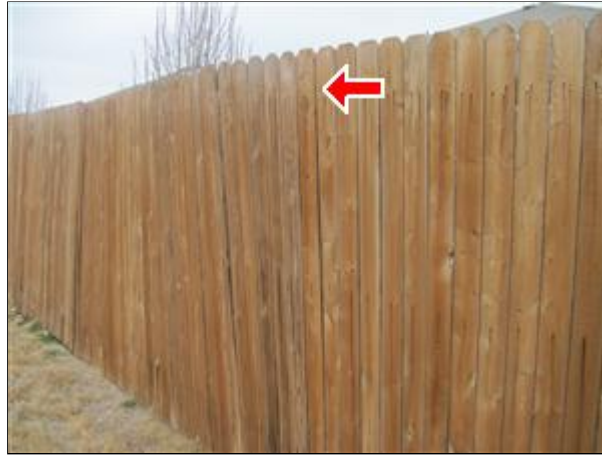
L. Picture 2

(2) Observed broken fence post at rear fence.

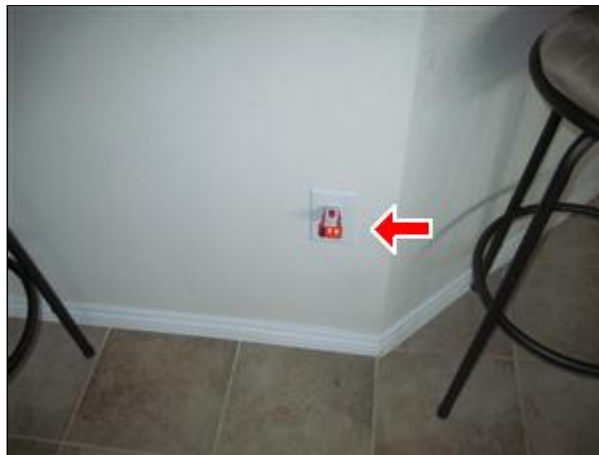
B. Picture 1

(4) Outlet pictured requires GFCI protection. Repair to meet code.

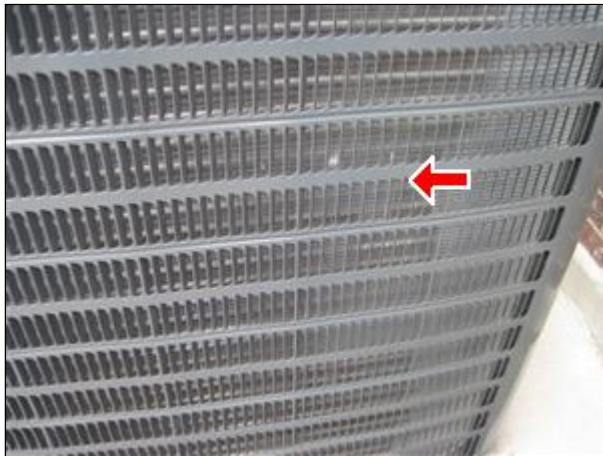
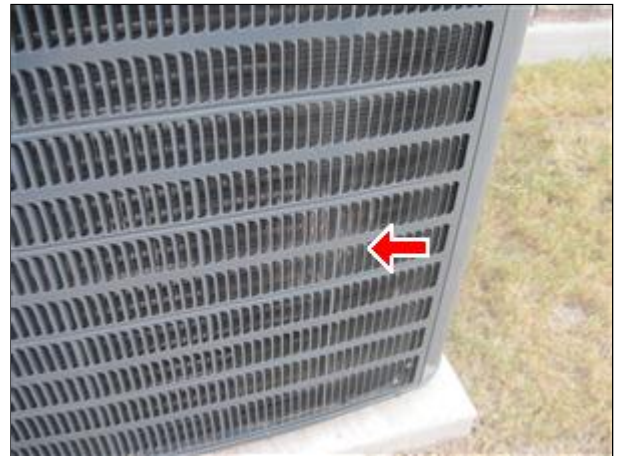
(2) Condenser Coil fins observed to be damaged/bent, need to be straightened to improve air flow/efficiency.

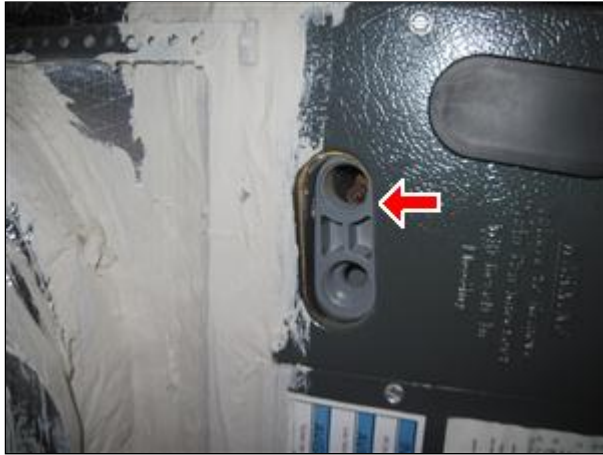
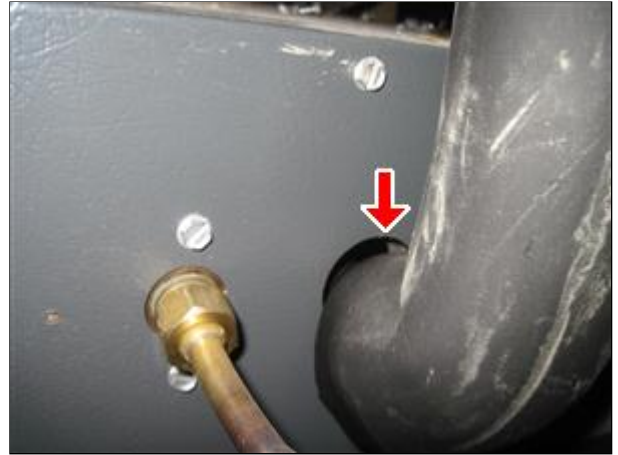
(3) Grommets/sealant missing around ac lines and or evaporator compartment openings. Allows air to escape unit and should be replaced/repared to improve efficiency.

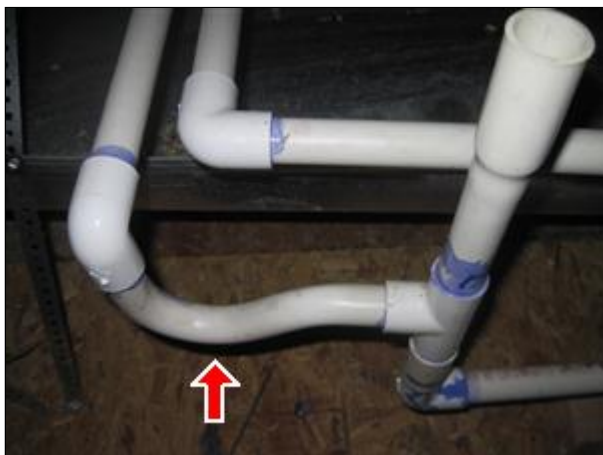
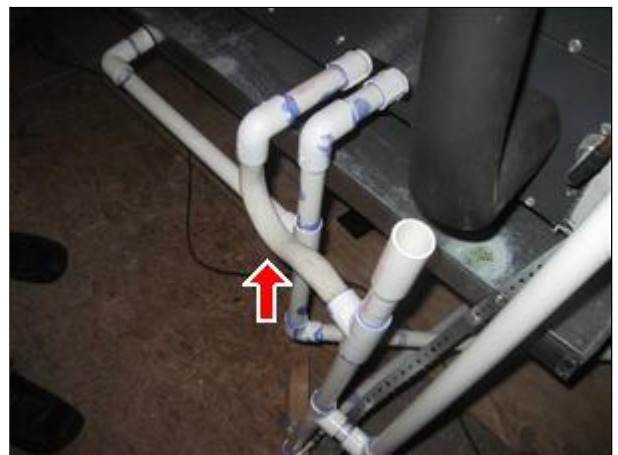
(5) Primary condensate drain line(s) trap(s) was/were not insulated. As of September 1, 2000, the Texas Real Estate Commission requires inspectors to identify the absence of insulation on the air conditioning

primary condensate line as an item in need of repair. The insulation prevents condensation from dripping in the home.

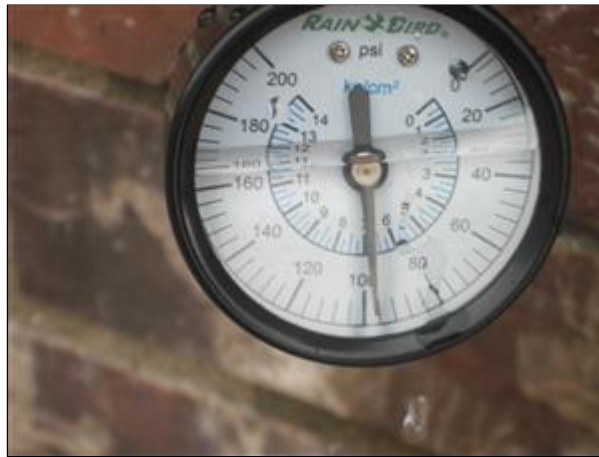
A. Picture 1

(1) Static Water pressure reading taken at exterior faucet observed to be 95psi. Pressure reading was above the 40 - 80 psi range considered normal. High water pressure may result in abnormal stress on plumbing fixtures and fittings, noisy or "knocking" pipes, drips and leaks. This condition is generally caused by city supply pressures. Pressure reducing valves exist that can help lower and regulate the water pressure coming into the home. Recommend review and consultation by a licensed plumbing contractor regarding problem causes and possible solutions.

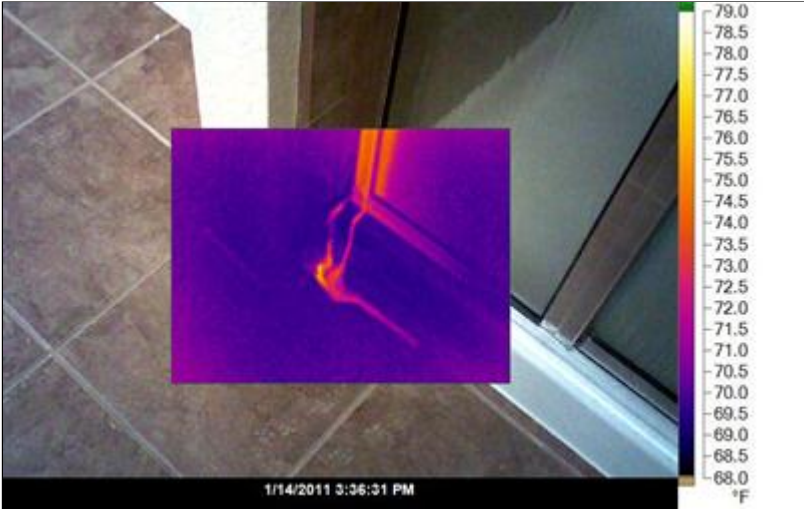
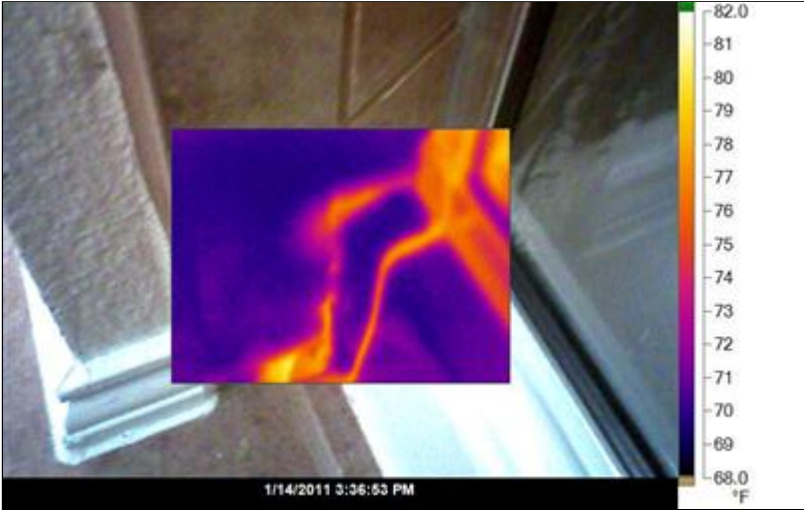
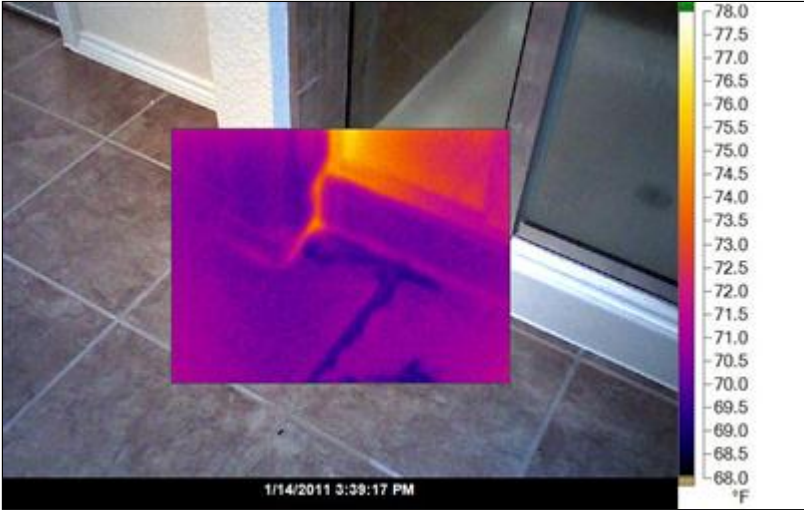
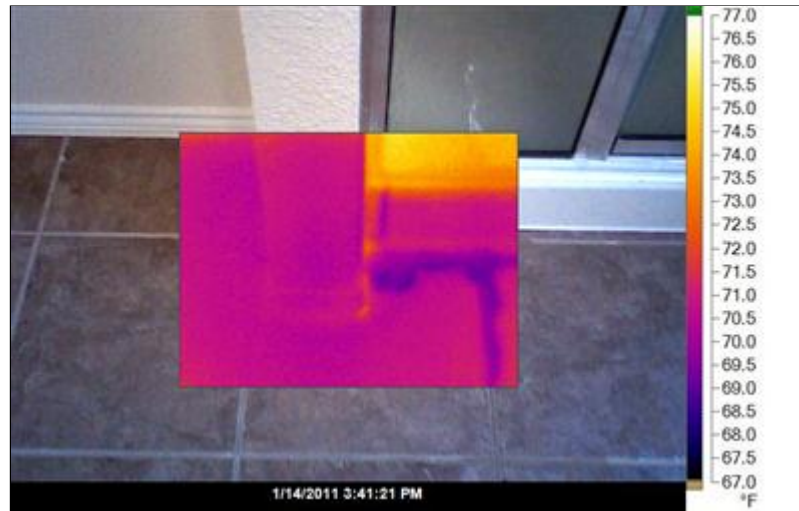
(2) Active leaks detected in master shower area. Infrared Thermal Imaging found active moisture outside of the shower enclosure. Excessive moisture content was confirmed by a moisture meter. Determining the extent, time-frame, or damage caused by leakage is beyond the scope of this inspection. Review and repair by qualified tile expert needed. ***We strongly recommend that testing, by a state licensed mold inspector, be completed to confirm no health risk due to organic growth before commencement of any repair work.*** Recommend complete removal, evaluation, and remediation by licensed specialist, as needed based on licensed mold inspector's findings. The whole process should be supervised by this specialist with appropriate testing completed before and after remediation is completed. After all testing and repair work has been completed, you should be provided written documentation certifying the quality of repair and the fact that the area is moisture free and no potential health hazards from organic growth are present.

Leakage from the shower enclosure indicates improper installation of the moisture barrier under the tile. When properly installed this system will NOT allow moisture to escape the enclosure. Due to the fact that a complete evaluation of the moisture barrier installation is not possible due to it being inaccessible for inspection and the leakage discovered we recommend that the shower enclosure and tile be completely removed and reconstructed.

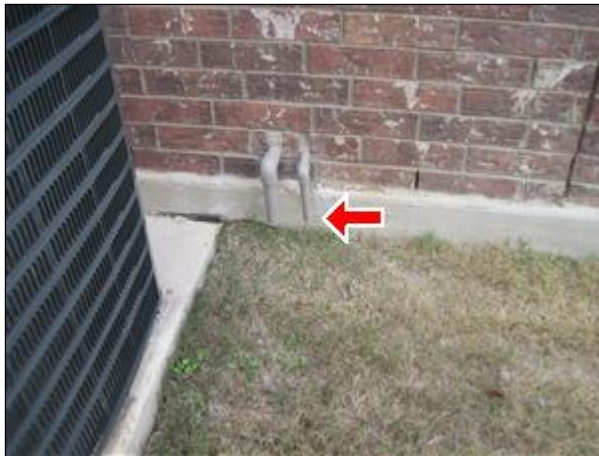
C. Picture 1

(3) T & P Drain line is improperly routed. End of pipe should be approximately 6" from ground, pointed down, and unobstructed. Repairs are required for safety.

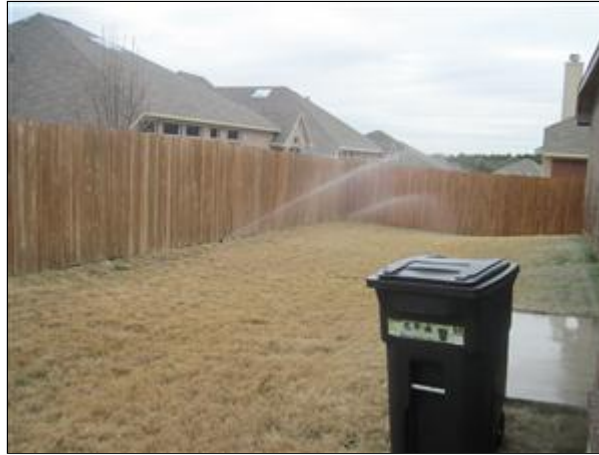
A. Picture 1

Adjust heads in zone 7 so that they do not spray on the house.
