Inspection Report

1 Year Old With Foundation Problems

Property Address:
1234 Foundation Fail Trail
Prosper TX 75078

PROPERTY INSPECTION REPORT

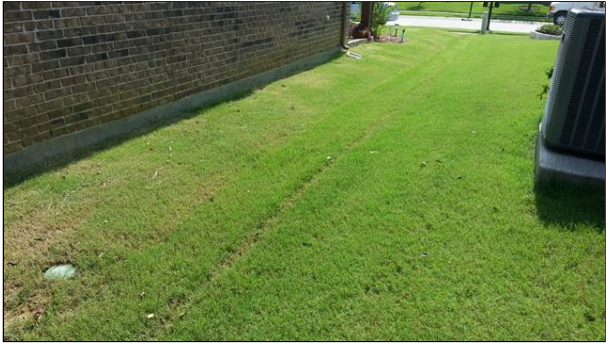
B. Item 1(Picture)

(2) "Low spots" were observed in some areas of the property where water appears to be pooling or could pool. This indicates that proper drainage off of the property is not occurring. Recommend further investigation and repair as needed. Repair options include but are not limited to: regrading and the installation of surface drain systems. Drain systems are much more effective solutions than regrading, in our experience. We recommend that drains be added if regrading has been attempted and failed to resolve the problem. Locations include but are not limited to : South side of home

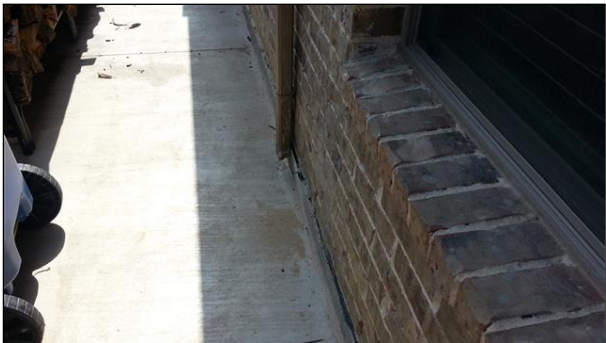
B. Item 2(Picture)

(3) Observed gutter downspout(s) that are missing the bottom elbow piece to properly route water. This condition is detrimental to the performance of this system. Recommend review and repair as needed by a qualified contractor. Locations include but are not limited to : north side

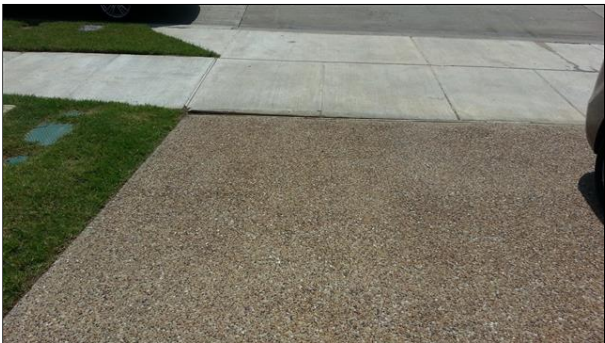
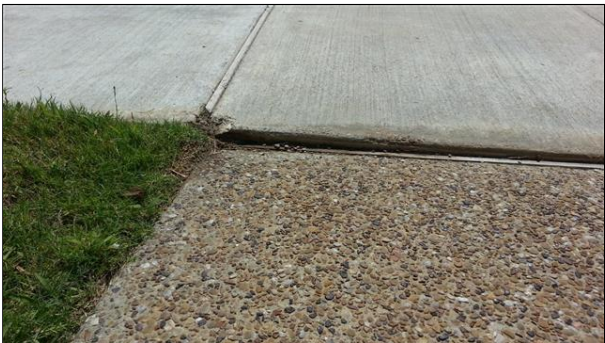
(4) Settlement of over an inch observed at Northeast corner or driveway slab where it meets the sidewalk. Recommend review and repair as needed by a qualified contractor.

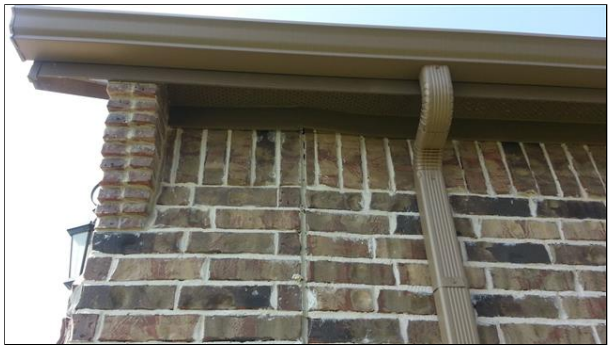
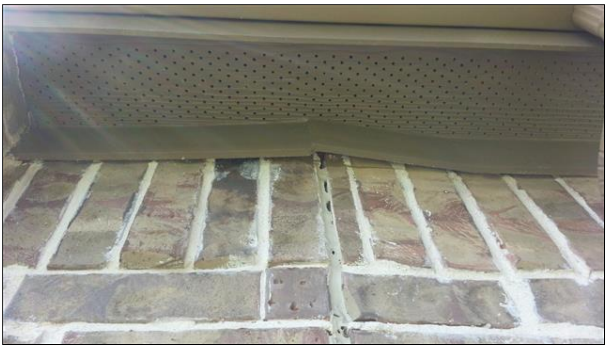
(2) Expansion joint pictured on North side is separated at top and frieze board is pulling away from wall. Possible indication of abnormal foundation movement. Recommend review and repair as needed by a professional engineer licensed by the state of Texas.

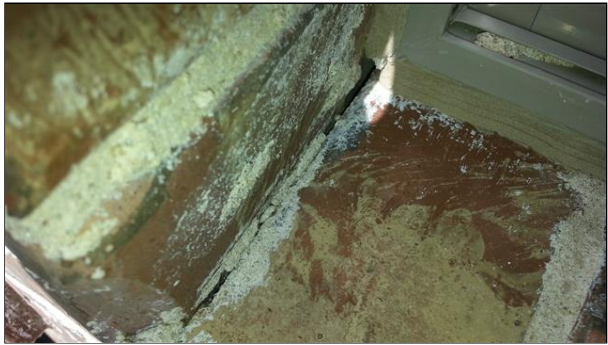
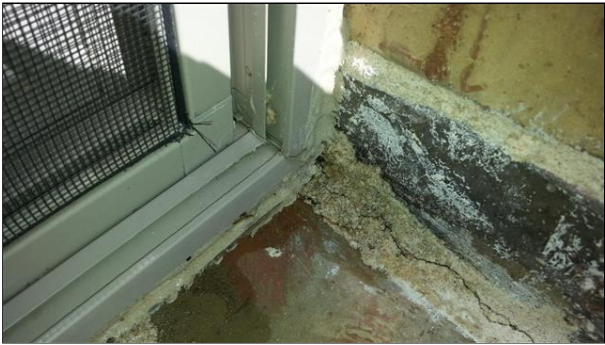
(3) Sill brick corner cracks were observed. This is a common place for normal movement to cause cracking. These areas should be sealed to prevent deterioration of the mortar and possible water penetration.

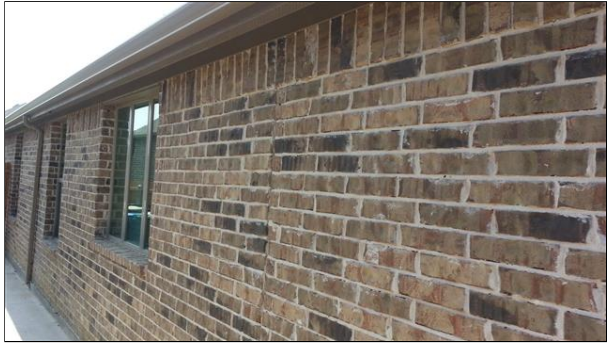
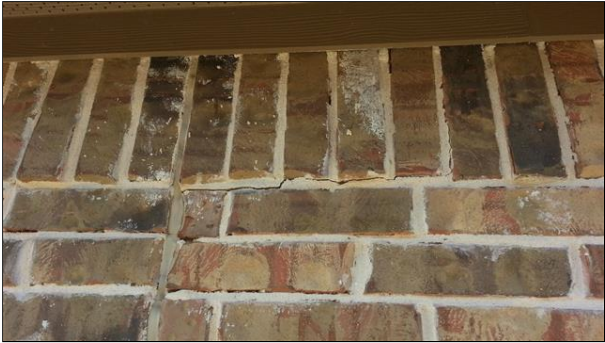
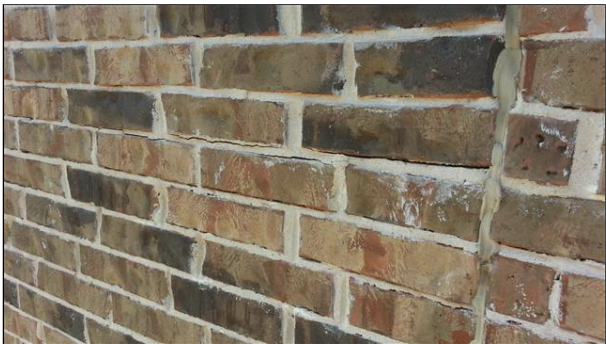
(4) Observed brick/mortar and or separation at window frame at brick that is consistent with structural deflection or movement. It is beyond the scope of this inspection to determine the extent, severity, or needed remedies related to this movement. I recommend that this be reviewed by a professional engineer licensed by the state of Texas. Locations include but are not limited to: north side

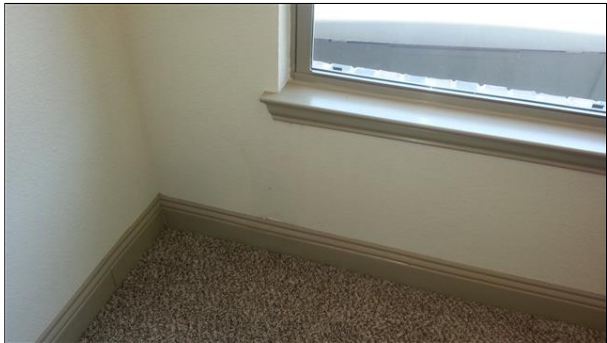
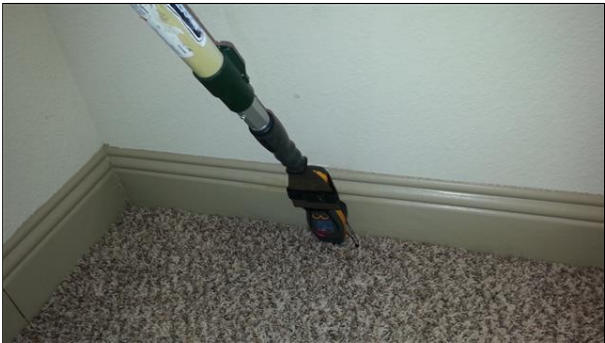
(5) Moisture damage observed in Drywall and trim inside home. Appears to be the result of damaged /improperly installed Windows. Recommend review and repair as needed by a qualified contractor. Testing for mold should be considered before beginning work. All affected materials should be replaced. Locations include but are not limited to : master bedroom

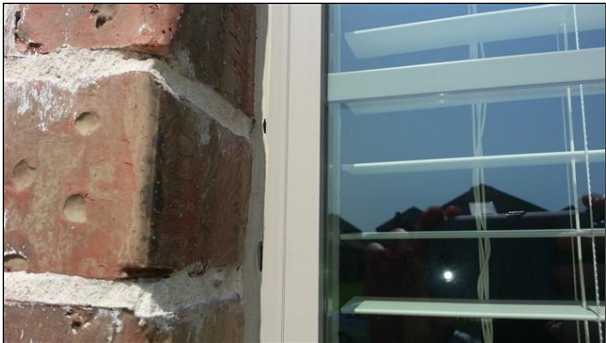
H. Item 1(Picture)

(2) Caulking touchup/repair is needed at various window exteriors. Caulking incomplete in corners / voids, cracked caulk or missing areas observed. All windows should be checked and improved as needed for optimum efficiency and to prevent possible water intrusion.

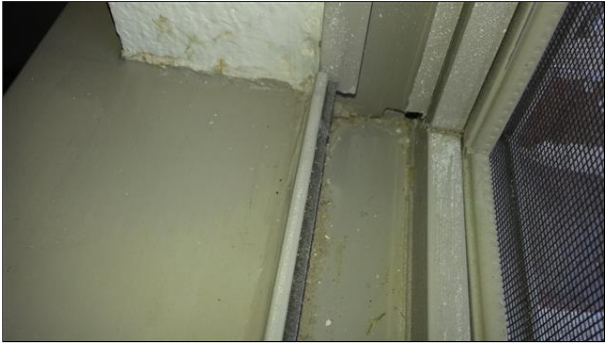
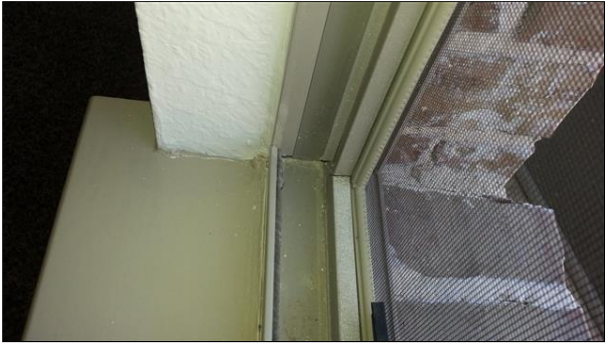
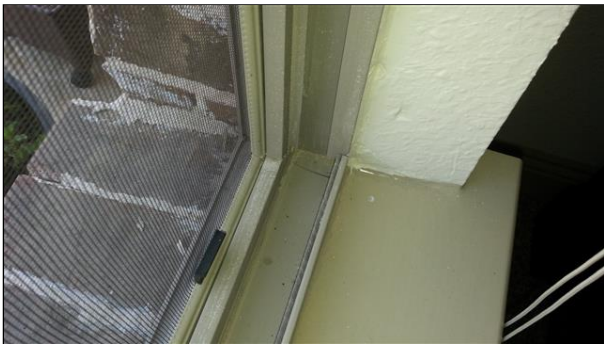
(3) Damaged / cracked window frames observed in home. Frames are cracked in bottom corners. Typically from poor and improper installation techniques. Condition can lead to water penetration into home. Recommend review and replacement s needed by a qualified contractor. If repair is deemed sufficient, such should be verified in writing by a window manufacturer's representative. Locations include but are not limited to : master bedroom

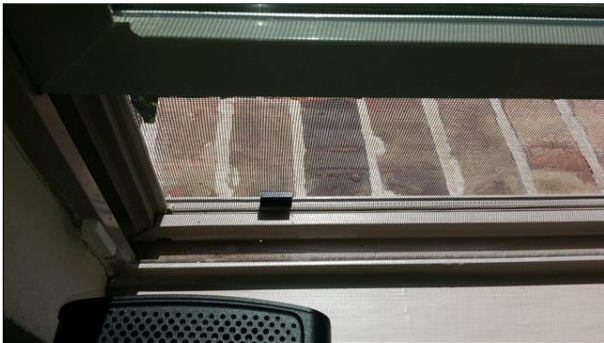
H. Item 5(Picture)

(4) Observed water standing in bottom of window frames. Indication of possible clogs in the weepholes preventing proper drainage. Recommend review and cleaning to allow proper drainage. Locations include but are not limited to : office /bedroom

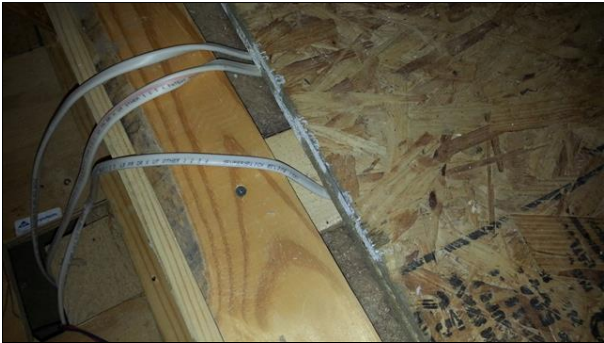
B. Item 2(Picture)

(3) Romex wire trapped under decking at walkway to furnace. Recommend review and repair as needed by a qualified contractor.

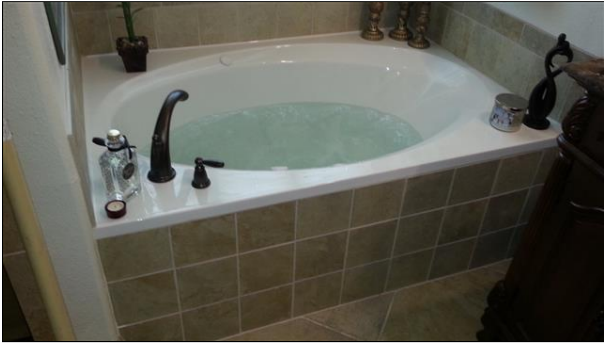
D. Item 1(Picture)

- (1) Was not able to access motor for visual inspection. Does not comply with National Electric Code (NEC 430-14) requiring that motor must be accessible for servicing.
