Inspection Report

One Year Warranty

1111 Year Old Ln
Prosper TX 75078

PROPERTY INSPECTION REPORT

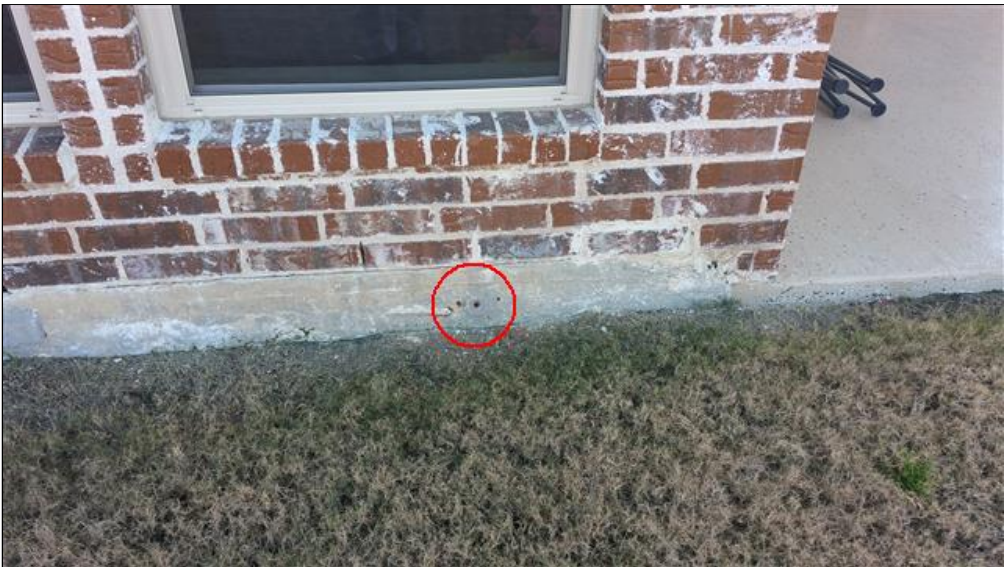
A. Item 1(Picture)

(2) Post tension cable live ends were observed to be exposed. These should be covered with non-shrink grout. Recommend repair by qualified contractor to prevent corrosion and possible failure of post tension cables over the span of years. Picture represents an example, entire foundation edge should be checked and repaired as needed.

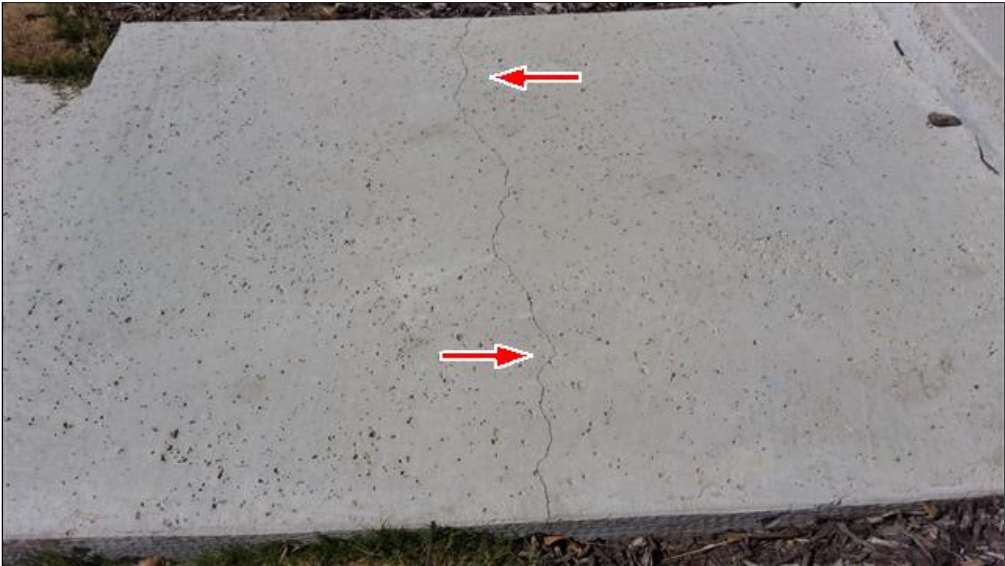
B. Item 1(Picture)

(2) Front walkway cracked. Appears to be cracked through and starting the shift. Recommend review and repair as needed by a qualified contractor.

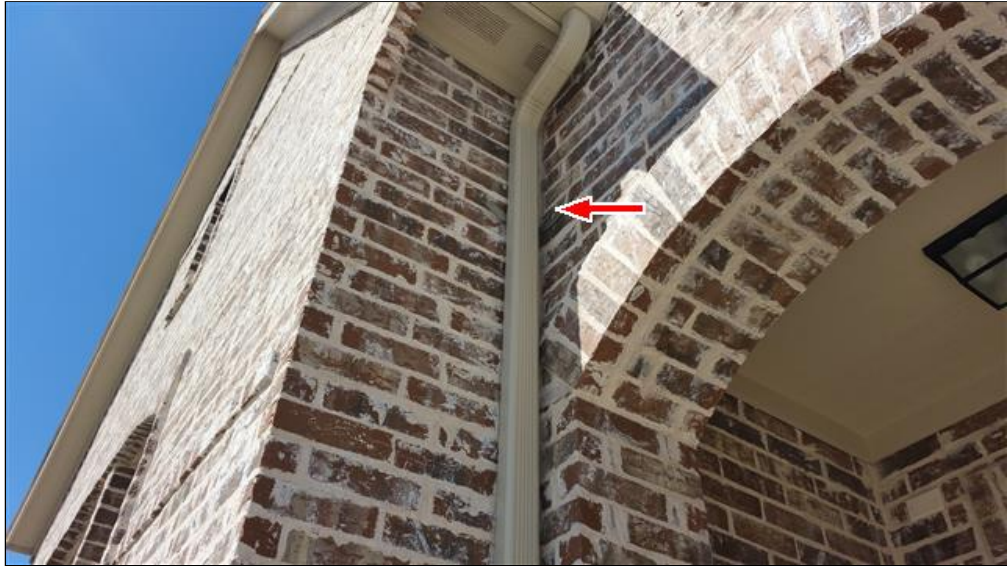
B. Item 2(Picture)

(3) Gutter downspout strap not secured. Recommend review and repair as needed by a qualified contractor. Locations include but are not limited to : front

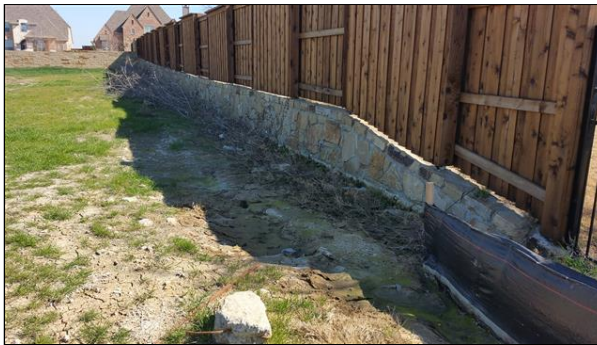
B. Item 3(Picture)

(4) Retaining wall present at rear of home. Ownership details unknown, recommend verification of ownership and maintenance responsibilities. Visual inspection only performed. No structural or engineering surveys performed. No warranties, guaranties are made or implied by this inspection.

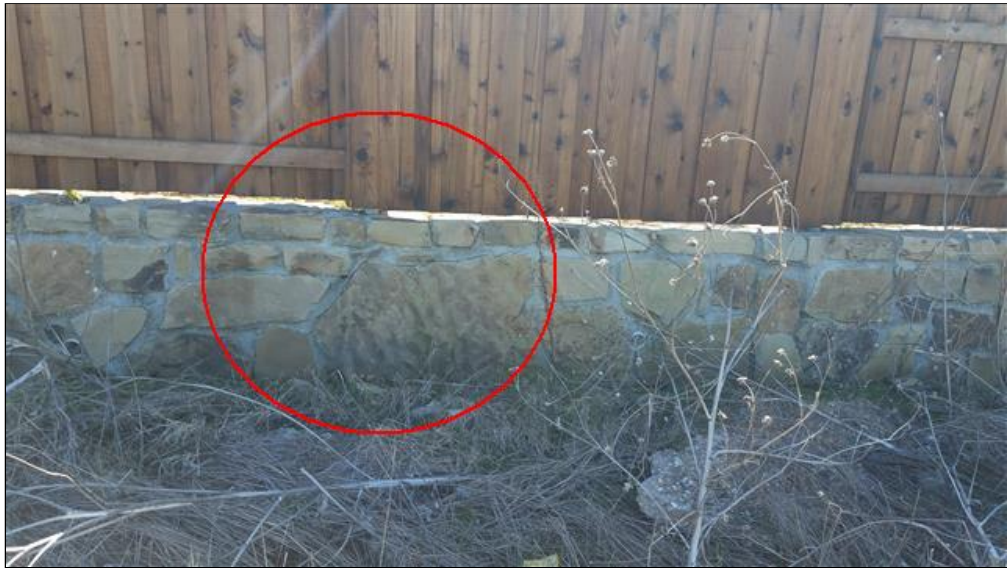
B. Item 4(Picture)

(5) Cracks and / or shifting were observed in retaining wall(s). It is virtually impossible for a home inspector to determine whether cracks are caused by structural failure or by some other cause, or, if caused by structural failure, whether the cause is active and ongoing. Recommend further evaluation by a licensed professional engineer or retaining wall specialist licensed by the state of Texas.

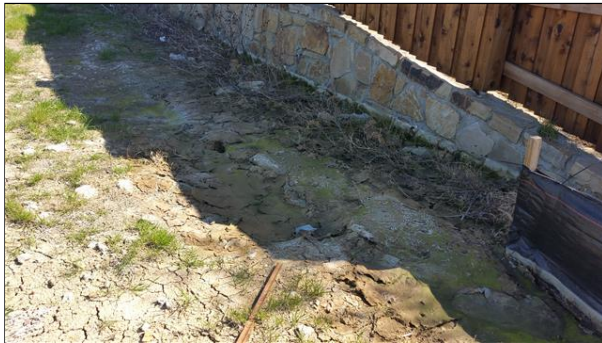
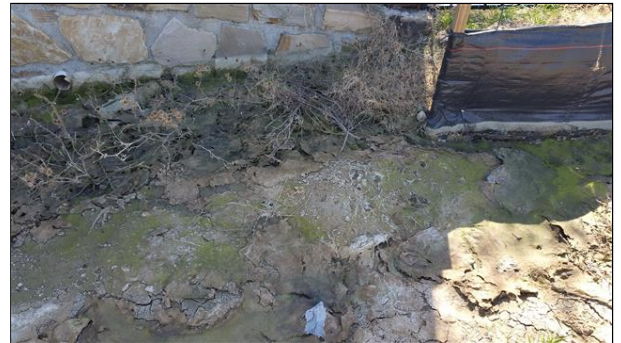
(6) Drainage at lower side of rear retaining wall (undeveloped / being developed land) is very poor. Appears to be holding water and maintaining excessive moisture. Could be detrimental to retaining wall performance and / or longevity. Recommend review and repair as needed by a qualified contractor.

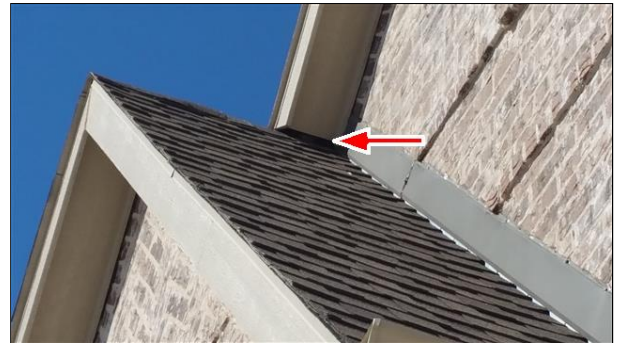
D. Item 8(Picture)

(3) Gap at soffit end / roof too large. Could allow pest entry to attic. Recommend filling /closing this gap.

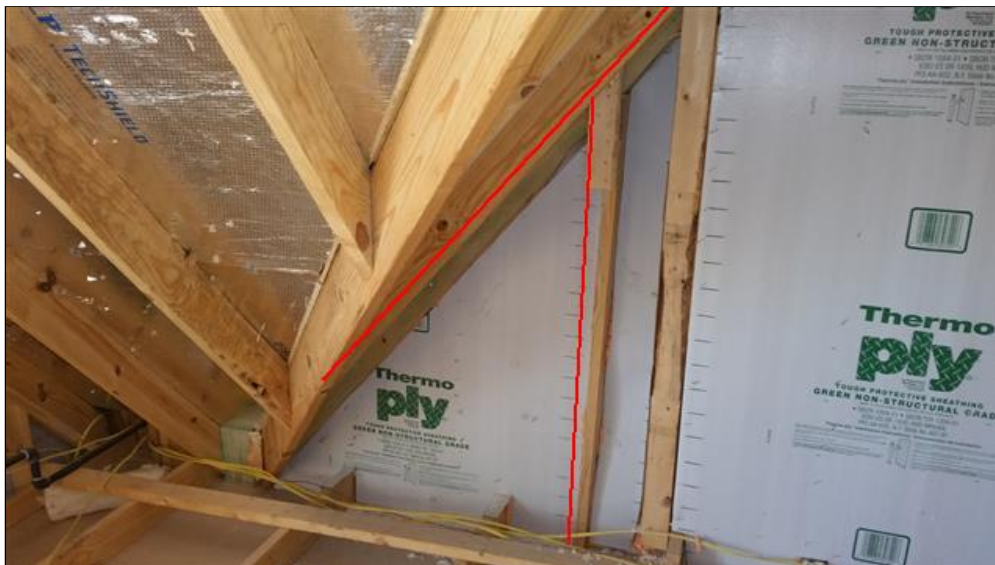
D. Item 11(Picture)

- 🏠 (6) Sister braced triple rafter at front roof area pictured in garage attic is not properly supported. Recommend adding additional supports and installing with "T" boards to prevent bowing. Recommend review and repair as needed by a qualified contractor.

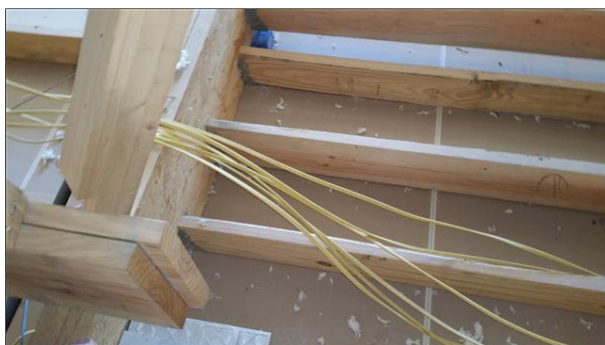
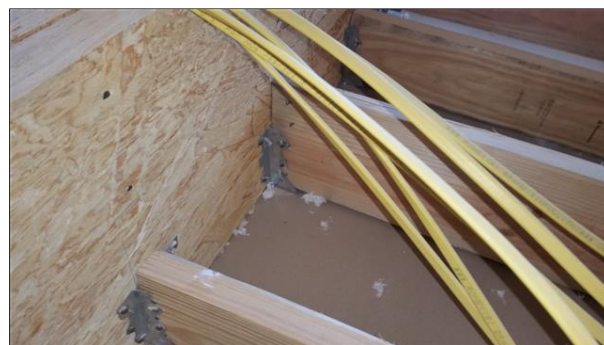
- 🏠 (7) Ceiling joists over garage are inconsistently sized. Recommend confirmation of required sizing and repair as needed by a qualified framing specialist or professional engineer licensed by the state of Texas.

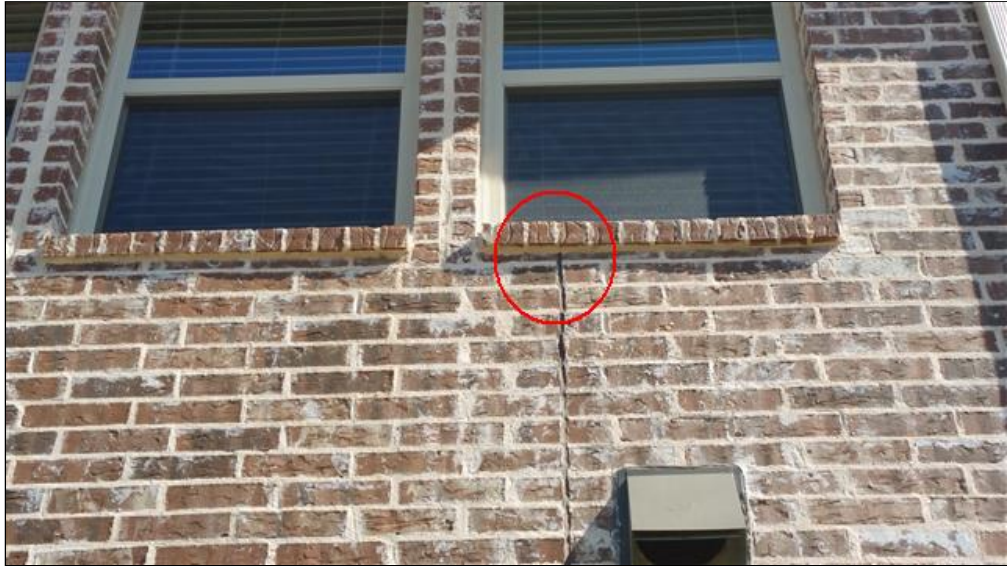
E. Item 5(Picture)

(4) Expansion joints not completely free of rigid mortar materials. By design expansion joints should be completely free of all rigid materials and should extend completely through the brick veneer height. Recommend removal of all rigid materials and reapplication of an appropriate elastomer type sealant in joint.

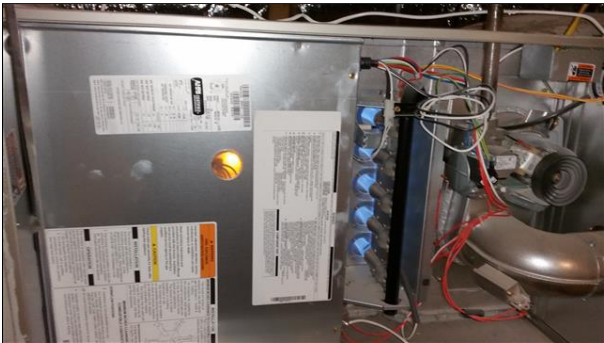
A. Item 1(Picture)

(1) Thermostat builder control locks in place. Maximum heat setting of 70. Could not test upstairs unit due to this limitation. Recommend review and repair as needed by a qualified contractor.
(2) We recommend that your heating equipment be serviced on an annual basis, before the start of the heating season. Annual service can help to keep the unit(s) running at peak efficiency, head off expensive repairs, and assure safety by checking for heat exchanger failures.
(3) Inspection of the integrity of the heat exchanger(s) is specifically excluded from this inspection. This part of the unit is not visible without major dismantling of the furnace, which is outside of the scope of the inspection.

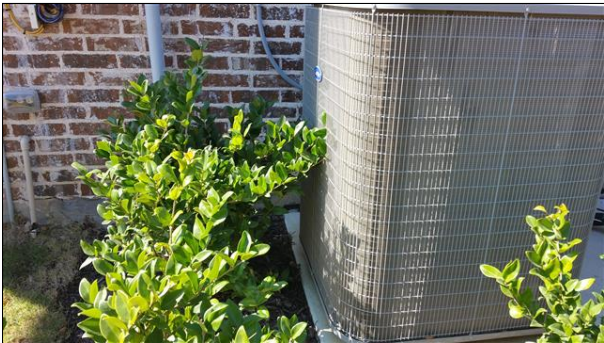
B. Item 2(Picture)

(2) Vegetation touching cooling condenser. Maintenance concern. Condition can lead to excessive deterioration and decrease the life expectancy and efficiency of the cooling condenser. Also recommend having soil and vegetation cleared away from the two lines to help prevent advanced deterioration and damage.
