Inspection Report

Shower Leakage

Property Address:
911 Shower Leaking Lane
McKinney TX 75070

PROPERTY INSPECTION REPORT

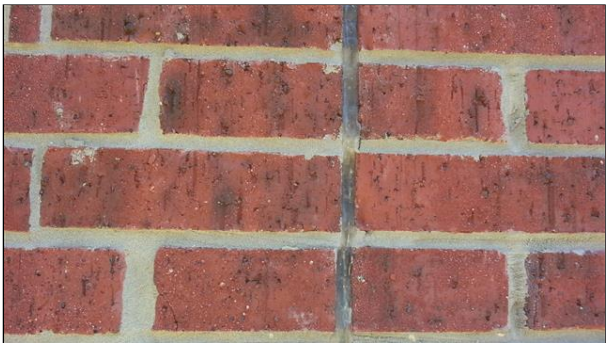
E. Item 1(Picture)

(2) Expansion joints not completely free of rigid mortar materials. By design expansion joints should be completely free of all rigid materials and should extend completely through the brick veneer height. Recommend removal of all rigid materials and reapplication of an appropriate elastomer type sealant in joint.

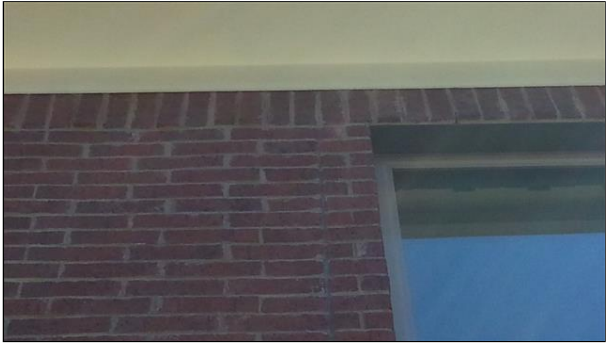
E. Item 2(Picture)

(3) Expansion joint pictured is improperly constructed. Does not extend entire height of wall. Joint does not continue through top course of bricks. Expansion joints should extend entire height of brick veneer, be entirely free of rigid materials and be sealed with appropriate flexible silicone sealant. Recommend review by structural expert and repairs as needed. Locations include but are not limited to: Pictured

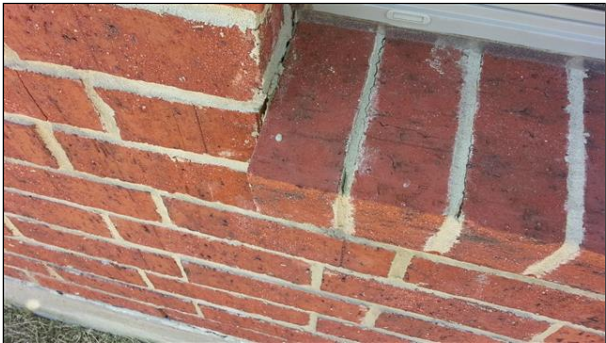
E. Item 3(Picture)

(4) Sill brick corner cracks were observed. This is a common place for normal movement to cause cracking. These areas should be sealed to prevent deterioration of the mortar and possible water penetration.

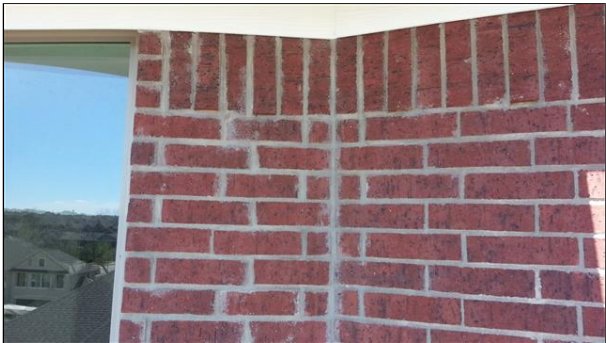
E. Item 4(Picture)

(5) Minor mortar cracking observed. Re-pointing/repair is recommended. Monitor this condition and take further action, including but not limited to evaluation by a structural engineer, if further movement is observed. Locations include but are not limited to: rear of home

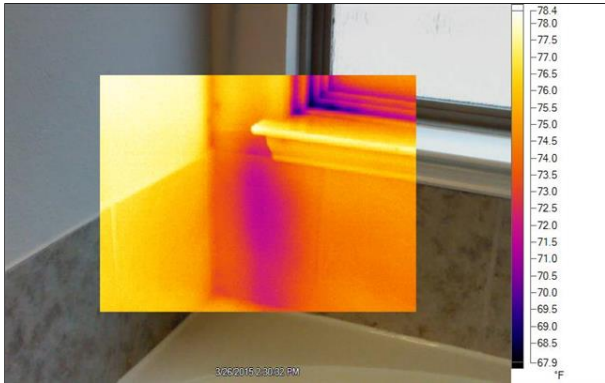
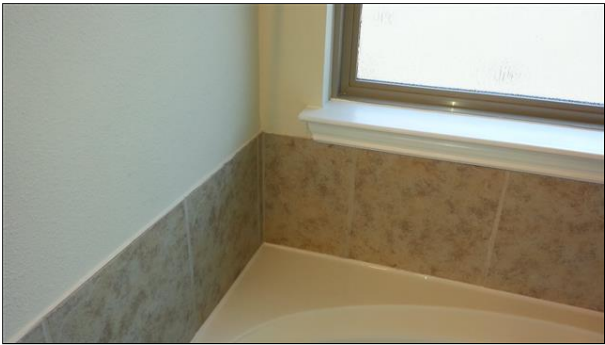
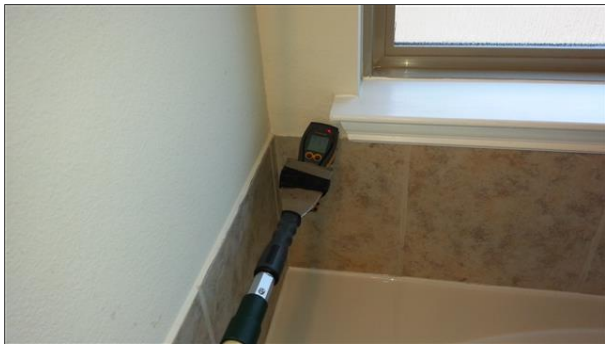
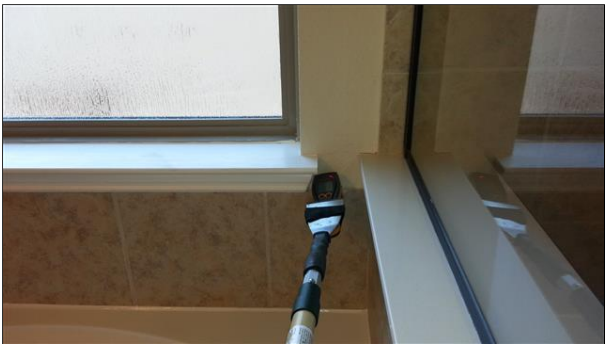
(6) Moisture indicators, dark colored spot(s), observed with infrared scan and excessive moisture content was confirmed with moisture meter. Exact source of leak unknown. Further investigation and repair needed. Consultation with specialist regarding remediation options and procedure should be considered if moisture damage is extensive. Locations include but are not limited to: upstairs Master bathroom window area

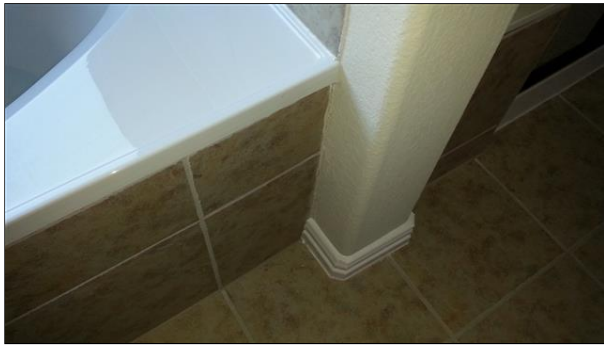
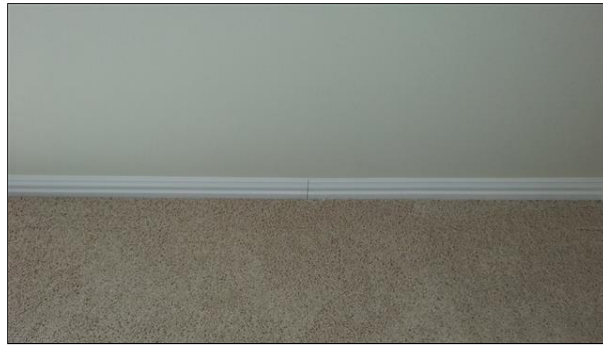
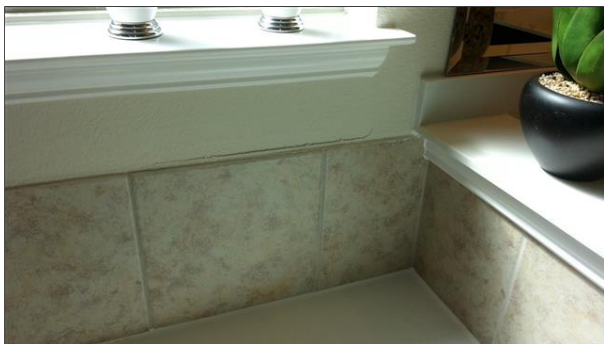
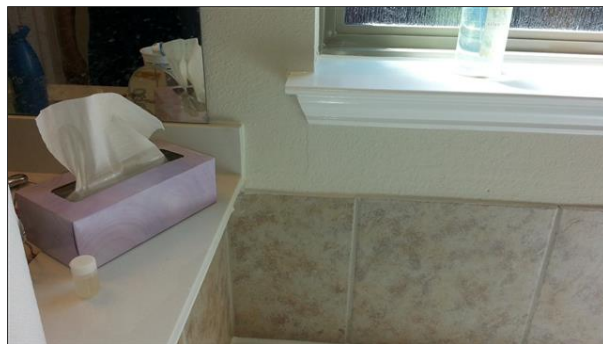
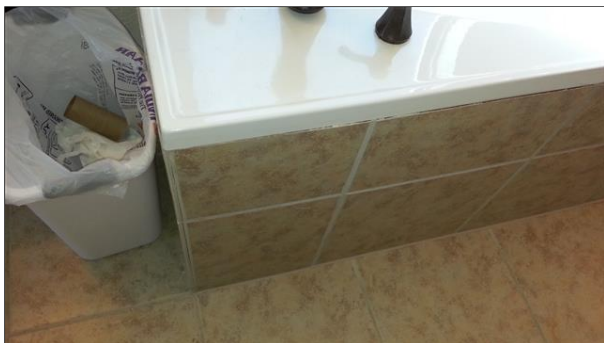
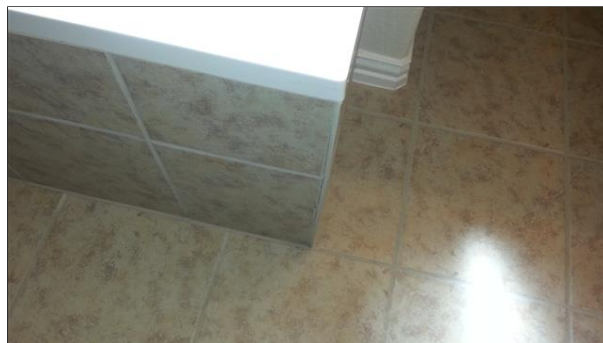
(7) Minor trim seam cracks, sheetrock cracks and tape joint cracks were observed in self evident locations throughout the home. These cracks are generally associated with normal foundation movements and wood shrinkage that occurs as the lumber dries out during the first year. Recommend cosmetic repair and continued monitoring of the area.

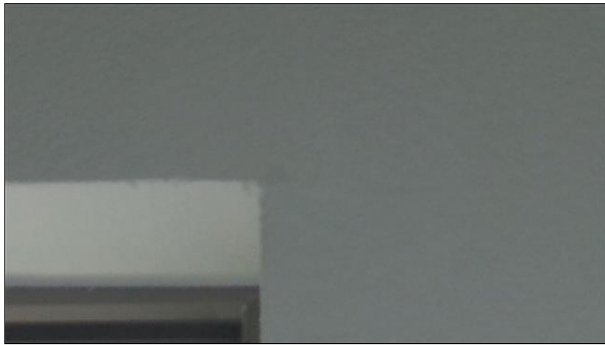
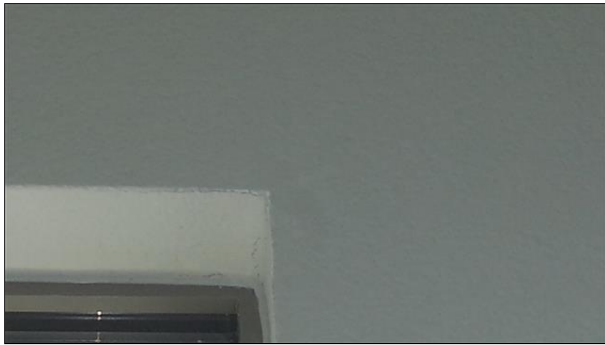
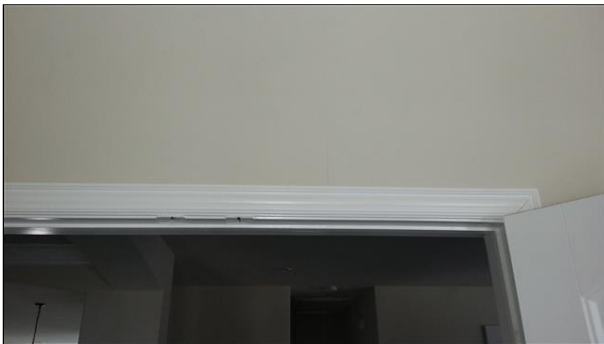
(8) Observed settlement type cracking in the interior walls. Recommend cosmetic repair and continued monitoring of these areas. If cracking continues or grows I recommend consultation with a professional engineer licensed by the state of Texas. Locations include but are not limited to: gameroom, media room

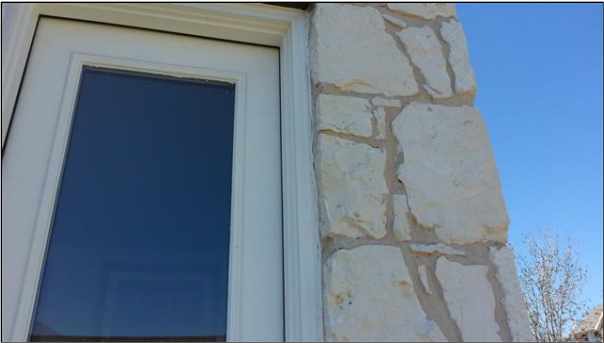
G. Item 1(Picture)

(2) Side door jambs caulking was dried, cracked and separating. This caulk is in need of repair or replacement. While caulking will become a normal maintenance item it should last longer than one year when quality materials are properly applied.

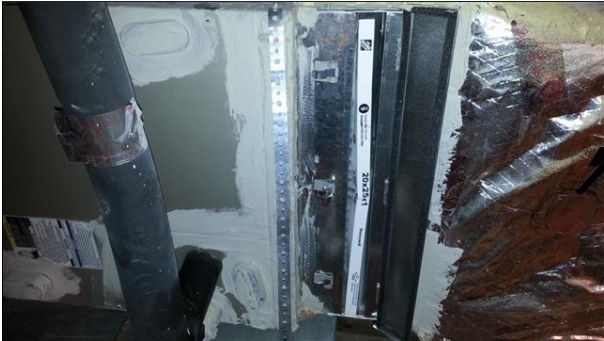
C. Item 1(Picture)

(3) Filters installed backwards. The airflow direction is from the filter into the cabinet / furnace / air handler. Filters with wire mesh screens should have the screen on the furnace side. Otherwise, the filter material can be drawn into the blower.

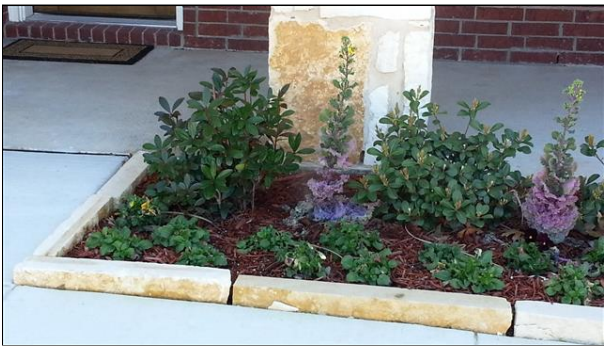
A. Item 1(Picture)

- ☒ (3) Broken line observed on zone 1 - flowerbed soaker. Repair by licensed irrigation specialist needed.
