Inspection Report

Property Address:
1234 New Construction
McKinney TX 75070

Absolute Inspections, LLC

PROPERTY INSPECTION REPORT

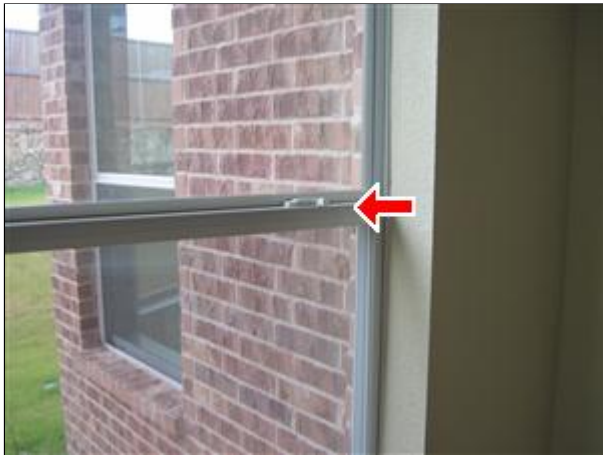
H. Picture 2

(2) Caulking repair is needed at various window exteriors. Caulking incomplete in corners / voids, cracked caulk or missing areas observed. All windows should be checked and improved as needed for optimum efficiency and to prevent possible water intrusion.
