Inspection Report

Property Address:
12345 Older Home Sample Report
Dallas TX 75238

Absolute Inspections, LLC

PROPERTY INSPECTION REPORT

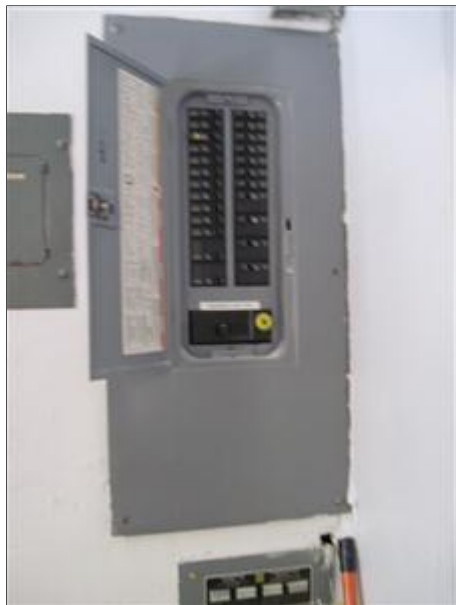
A. Picture 2

(1) Infrared Imaging revealed dangerously hot breaker in panel - high temperature reading exceeded 248 degrees F. Safety Fire Hazard. Inspector turned off breaker and informed the listing agent of the danger and action. Breaker was labeled "breakfast nook outlets." Labeling accuracy is questionable as further inspection revealed this breaker services the living room fan, main attic light and main attic air handler. Immediate review by a licensed electrician is needed for safety.

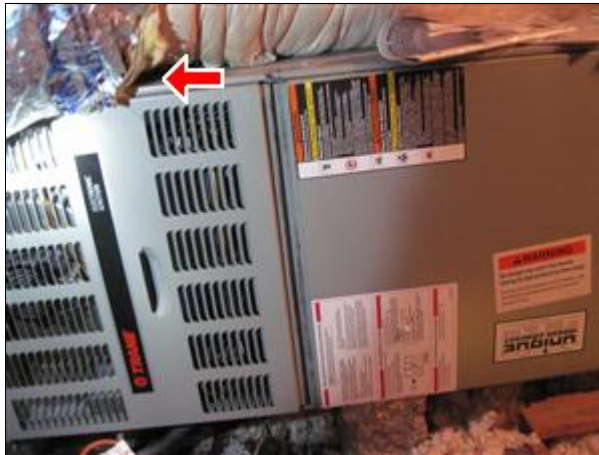
A. Picture 3

(6) Main area furnace cover was not removed due to ductwork blocking cover. Inspector could not get the cover off.

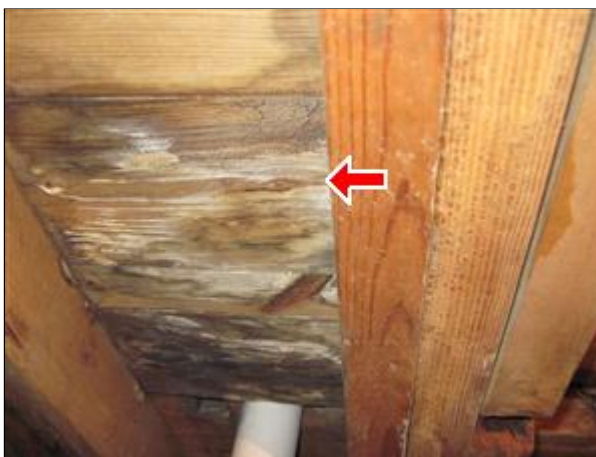
A. Picture 13

(4) Active leaks detected in master shower area. Infrared Thermal Imaging found active moisture outside of the shower enclosure. Excessive moisture content was confirmed by a moisture meter both at bathroom walls and underneath in crawlspace at floor boards. Determining the extent, time-frame, or damage caused by leakage is beyond the scope of this inspection. Review and repair by qualified tile expert needed. **We strongly recommend that testing, by a state licensed mold inspector, be completed to confirm no health risk due to organic growth before commencement of any repair work.** Recommend complete removal, evaluation, and remediation by licensed specialist, as needed based on licensed mold inspector's findings. The whole process should be supervised by this specialist with appropriate testing completed before and after remediation is completed. After all testing and repair work has been completed, you should be provided written documentation certifying the quality of repair and the fact that the area is moisture free and no potential health hazards from organic growth are present.

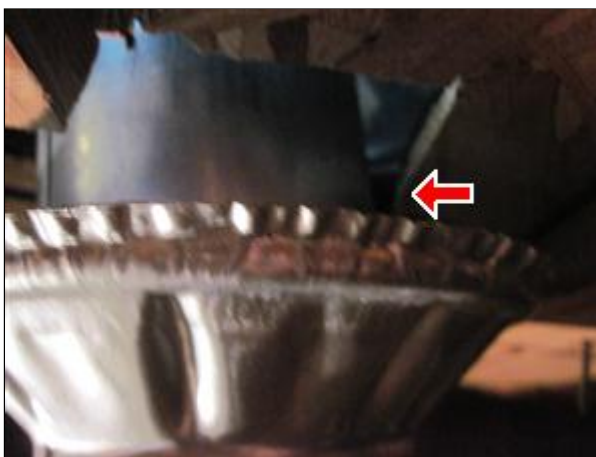
C. Picture 9 Flue close to combustibles
