Inspection Report

One Year Warranty

1111 Year Old Ln
Prosper TX 75078

PROPERTY INSPECTION REPORT

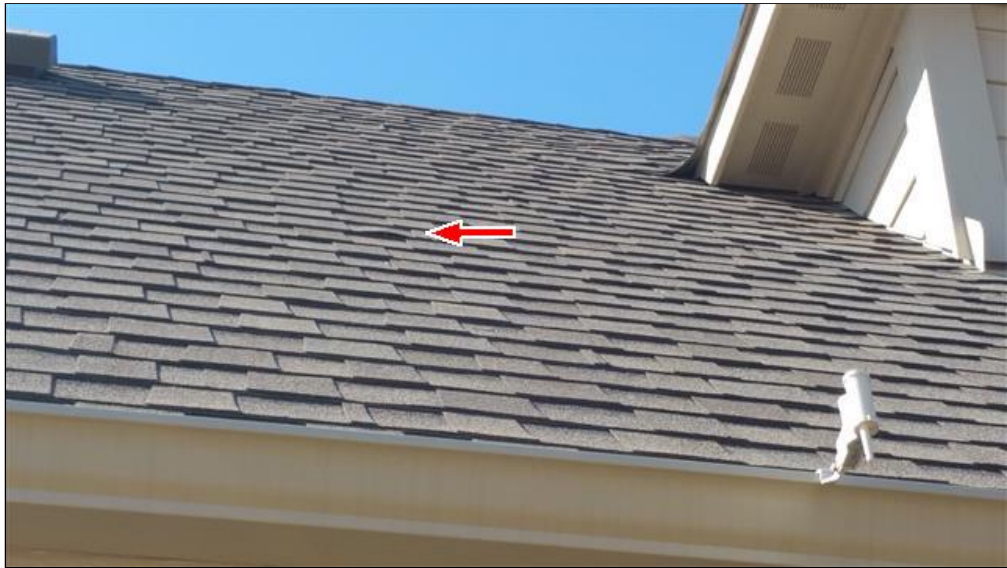
C. Item 5(Picture) East slope

(2) Roof was mounted and walked in a limited fashion due to the steep slope of some portions of the roof. Inspector typically walks the valleys and ridges and/or lower slopes to view the roof from above but did not walk on fields of the roof unless specifically noted. Parts of roof may be observed from ground due to the height and/or pitch of the roof making it unsafe for the inspector to walk. Some areas may not be visible and are not inspected.

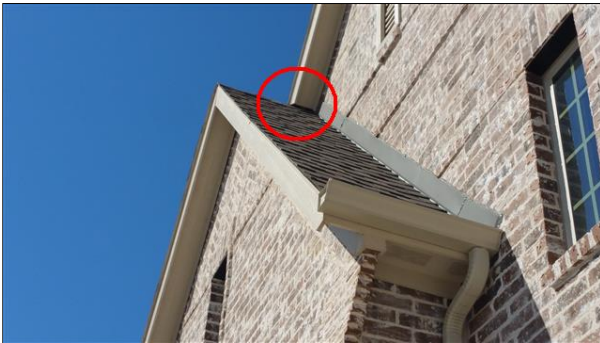
D. Item 7(Picture)

installation of caulking and or flashing can lead to leakage. These areas should be monitored regularly and maintained as needed

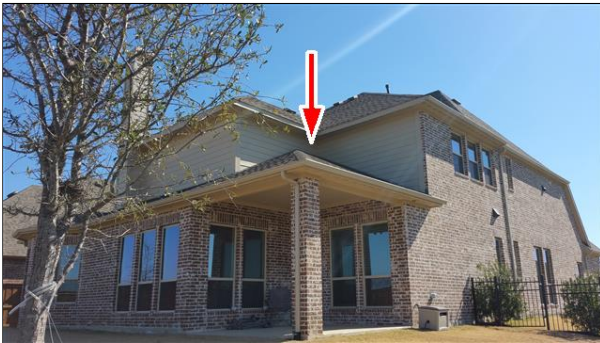
D. Item 9(Picture)

(3) Gap at soffit end / roof too large. Could allow pest entry to attic. Recommend filling /closing this gap.

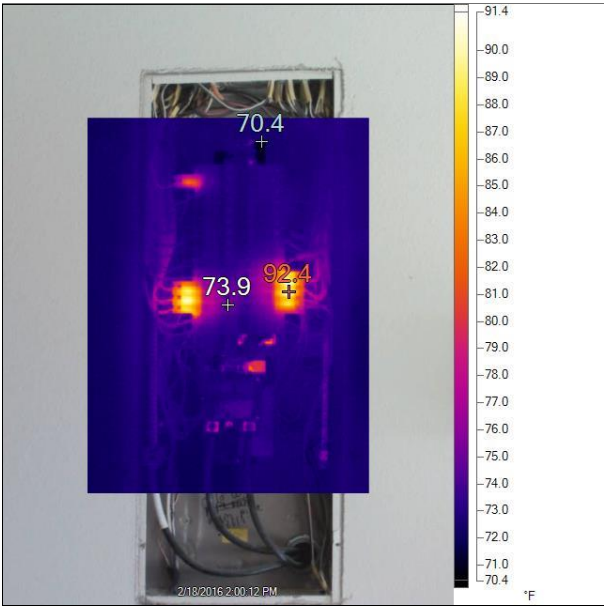
A. Item 3(Picture)

(1) Circuit breaker panel was labeled. Inspector does not verify the accuracy of this labeling. You are recommended to verify all circuits yourself to confirm that labeling is accurate.

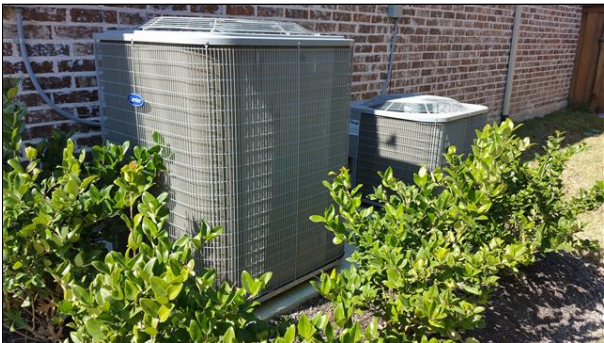
B. Item 1(Picture)

(2) Vegetation touching cooling condenser. Maintenance concern. Condition can lead to excessive deterioration and decrease the life expectancy and efficiency of the cooling condenser. Also recommend having soil and vegetation cleared away from the two lines to help prevent advanced deterioration and damage.

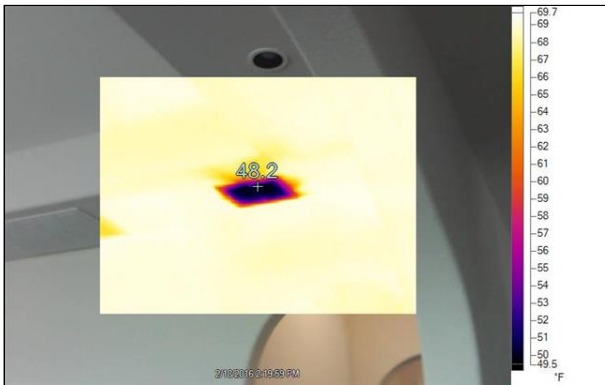
B. Item 3(Picture) Upstairs Supply Temperature

(4) AC unit appears to be functioning properly based on a one time limited inspection. Generally a differential of 14 - 21 degrees is considered normal. These temperature readings were taken at the

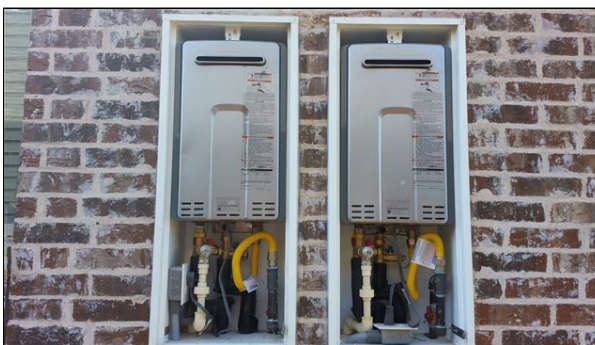
C. Item 1(Picture)

(1) Most manufacturers recommend that a tankless heater be flushed of impurities every six months to two years. A flush kit can be obtained from a licensed plumbing contractor. DIY kits are also available. I recommend that you check with your unit's manufacturer to determine exact schedules, techniques, etc. Tankless water heaters can last 20 or more years with proper maintenance.

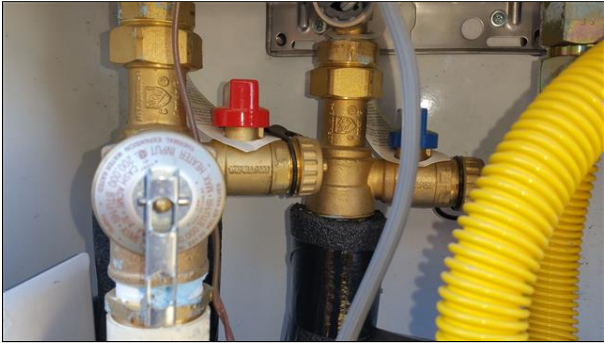
C. Item 2(Picture)

(3) Maintenance fittings installed in such a ways as to be blocked or obstructed. This condition will make require periodic maintenance difficult and is poor installation technique. Recommend review and repair as needed by a qualified contractor.

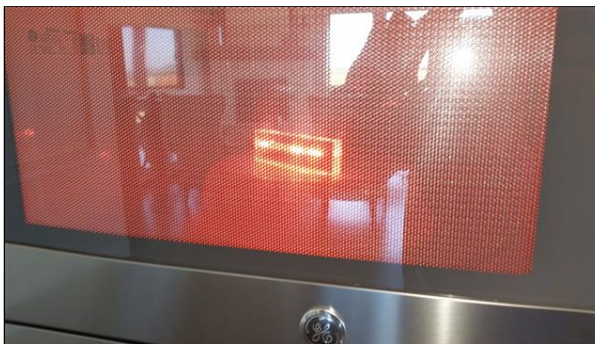
E. Item 1(Picture)

The microwave unit was inspected and appeared to be functioning as intended at the time of the inspection. Inspection of the microwave is for heating ability only. No radiation leak testing was completed.

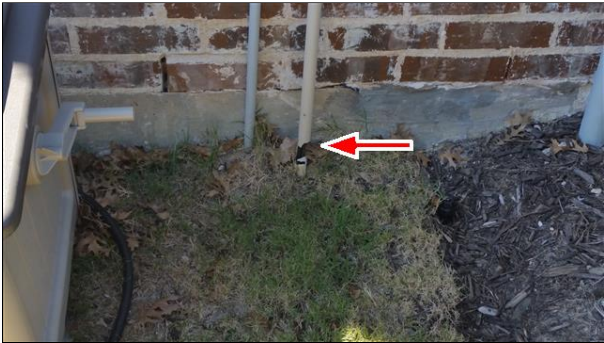
A. Item 1(Picture)

(1) PVC piping that protects the sprinkler wires as they enter the home is broken. Recommend repair of sealing.
- (2) Rain / Freeze sensor observed to be present. Operation of the sensor was not tested.
- (3) This irrigation system is equipped with buried soaker type hoses controlled by the automatic control. It is difficult and sometimes impossible to determine if or how well these zones are working because the soaker hoses are buried and not visible. Inspections of these zones is limited and you should check them regularly for signs of leaks. Soaker zones are generally installed with inline filters present at the valve boxes. Different manufacturers have different maintenance requirements for these filters. You are advised to discuss these requirement and the locations of the filters with your builder or a licensed irrigation specialist.
