Inspection Report

Shower Leakage

Property Address:
911 Shower Leaking Lane
McKinney TX 75070

PROPERTY INSPECTION REPORT

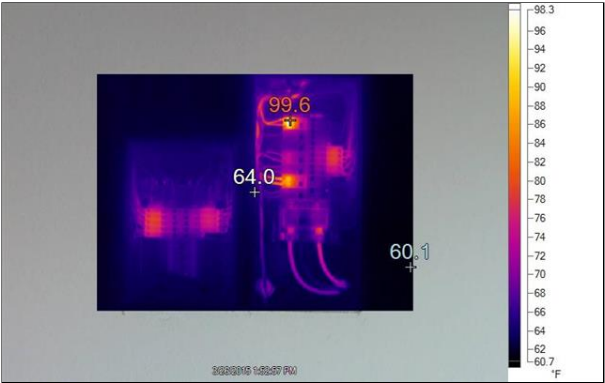
A. Item 2(Picture)

(1) Circuit breaker panel was labeled. Inspector does not verify the accuracy of this labeling. You are recommended to verify all circuits yourself to confirm that labeling is accurate.

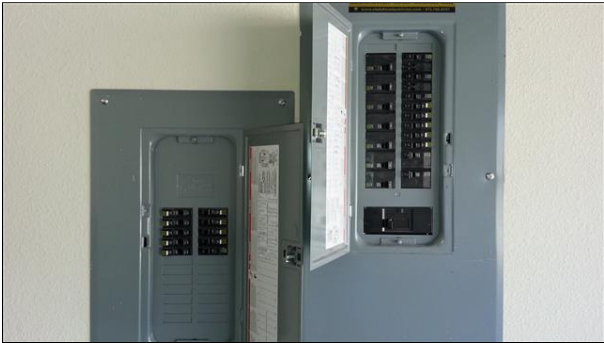
A. Item 3(Picture)

(2) AFCI circuit protection was not tested due to home being occupied and the potential for damage that could be caused by deactivating the circuits. AFCI circuits are not required to be deactivated in an occupied home. It is recommended that you tested these circuits by pressing the "test" button at the breaker panel monthly.
